## Windstorm Mitigation Report (OIR-B1-1802)

Pipers Glen Condominium Association, Inc.

1569-1575 Amberlea Drive S

As of 9/21/2023 | FPAT File# MIT2320608

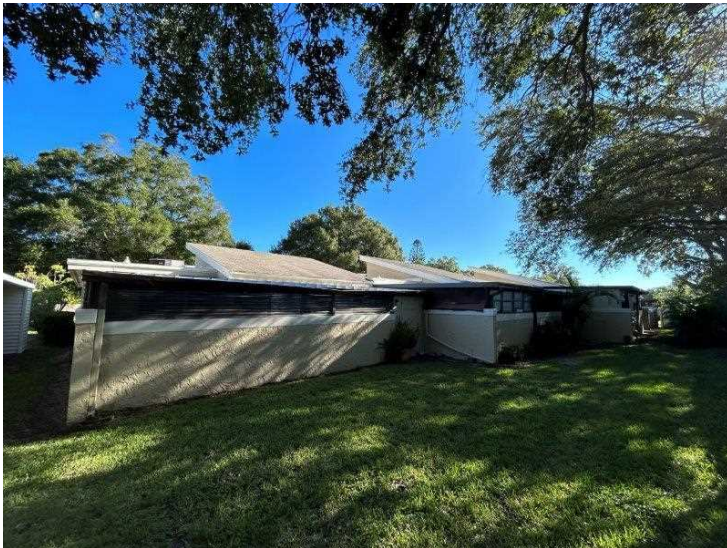
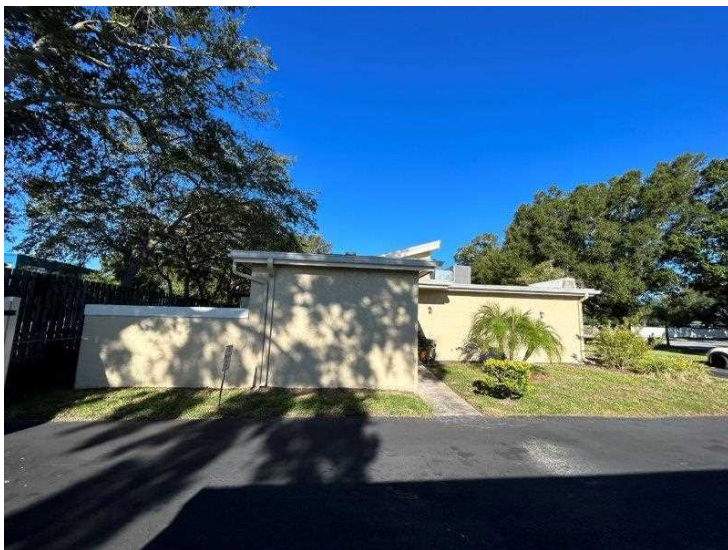
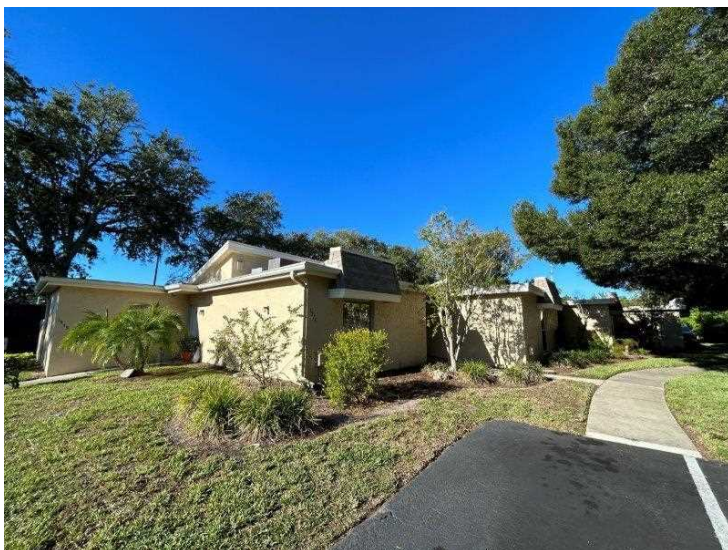
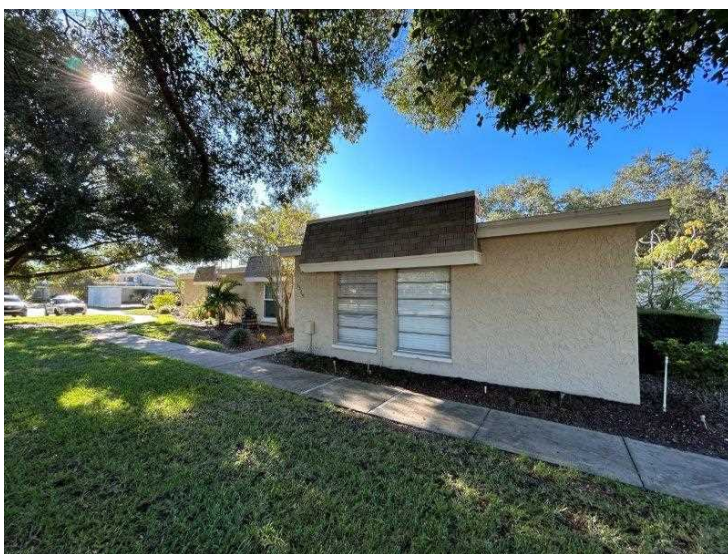
Exterior Elevation

| <b>5. Roof Geometry:</b><br>Comments: | <b>Other Roof</b><br>The roof shape is made up of a combination of flat and pitched sections. The flat area of the roof comprises approximately 71% of the total roof area. |
| <b>7. Opening Protection:</b><br>Comments: | <b>None or Some Glazed Openings</b><br>Inspection verified no opening protection. |

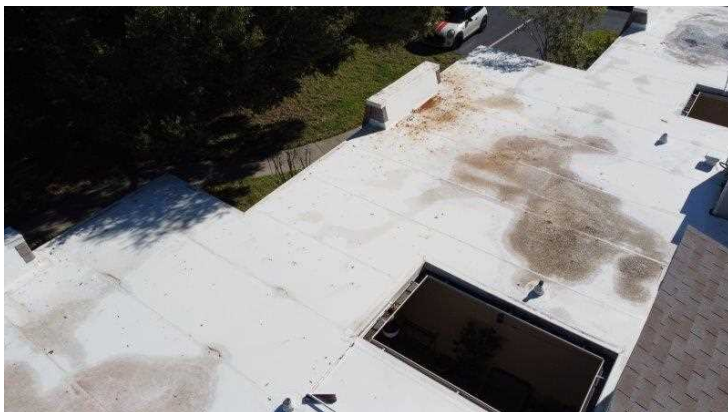
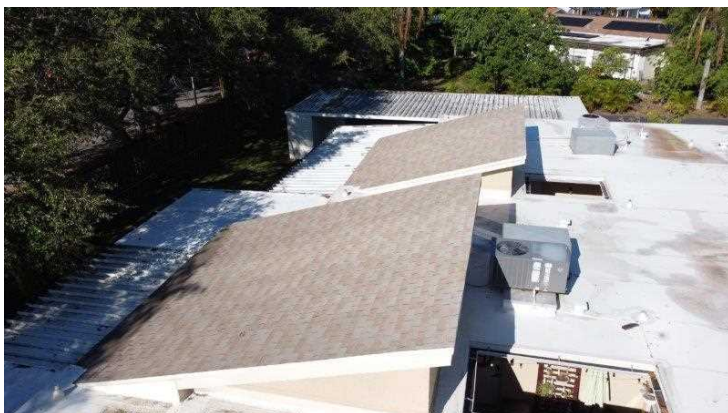
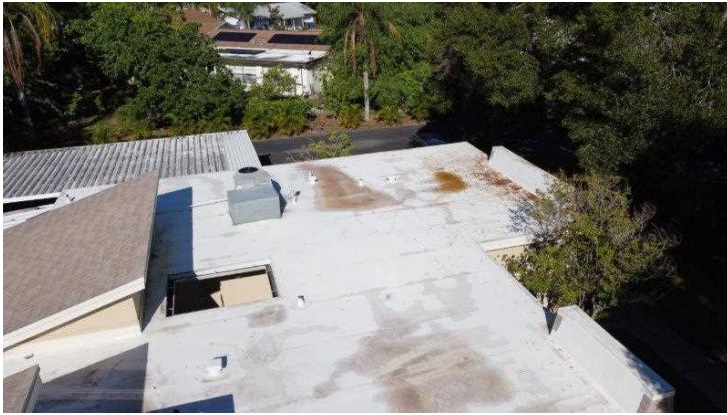
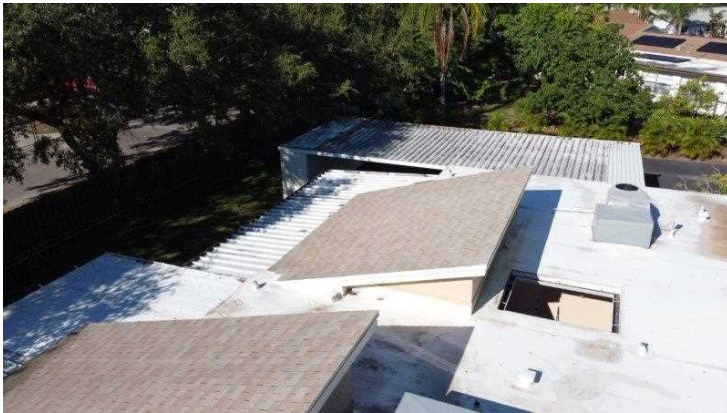
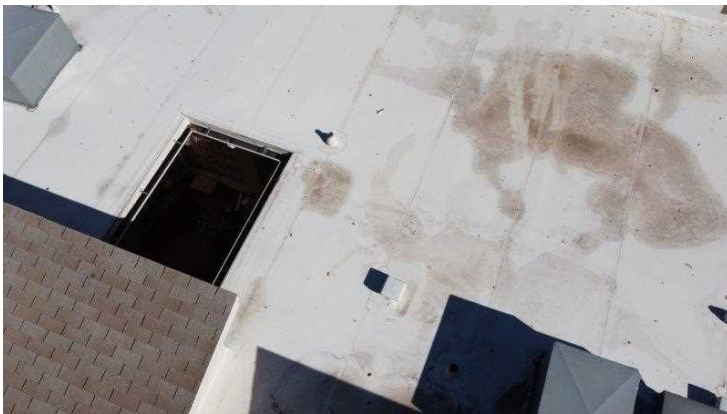
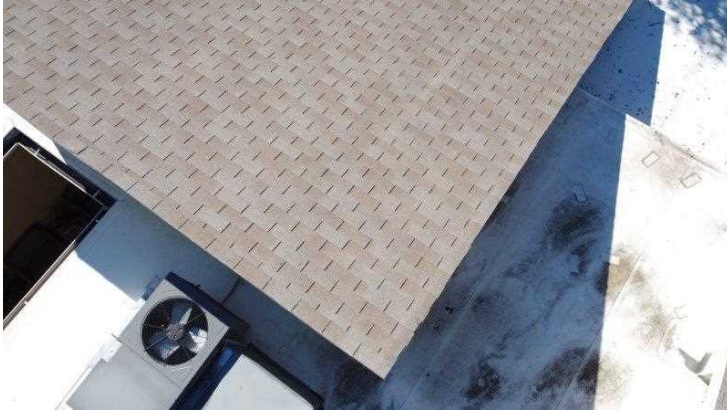
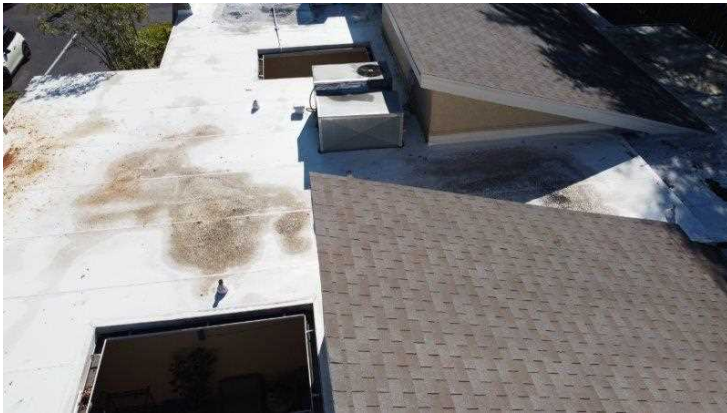
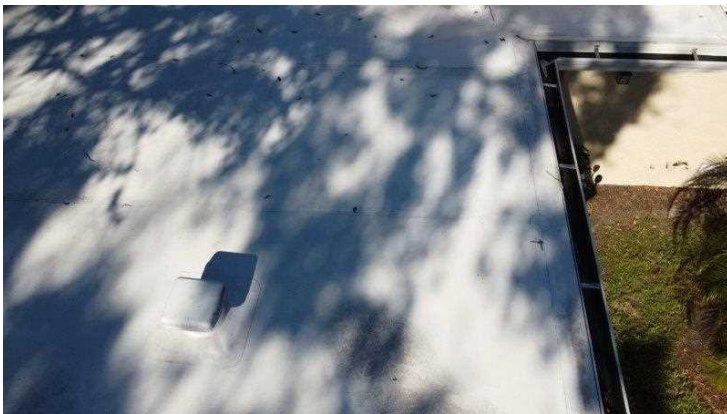
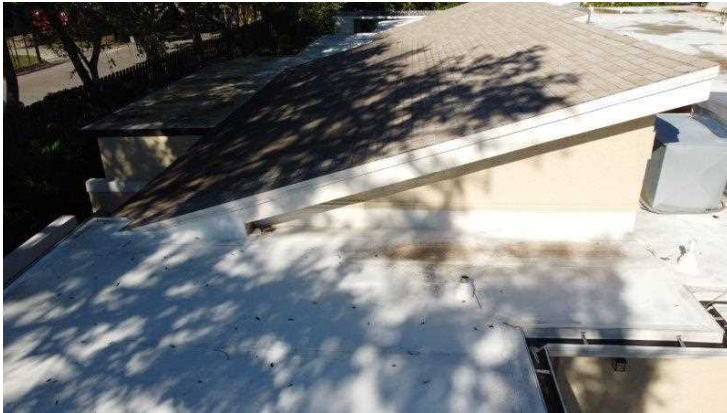
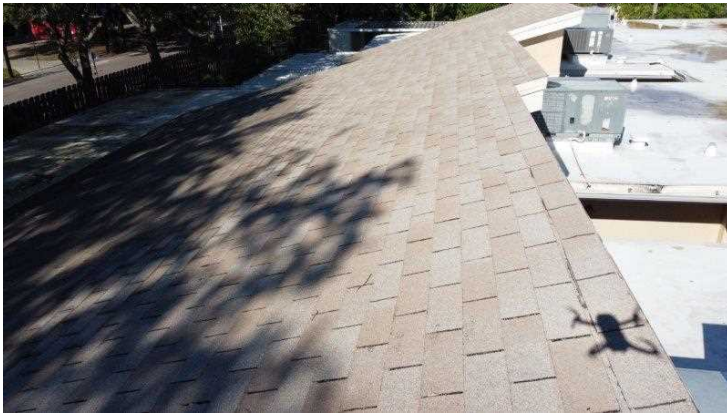
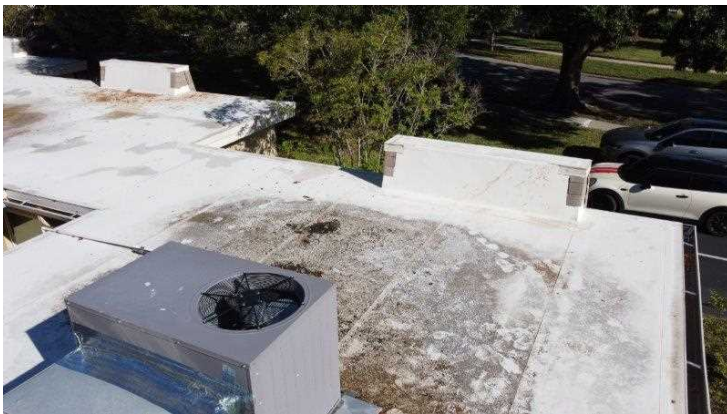
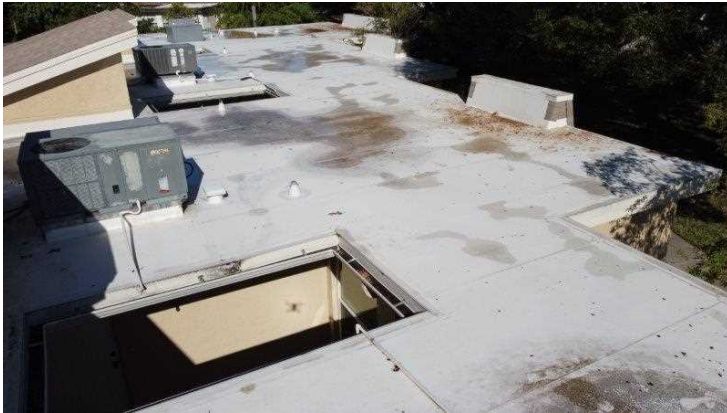
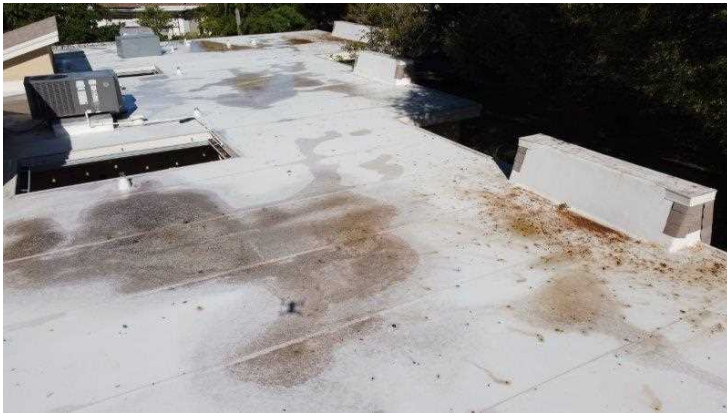
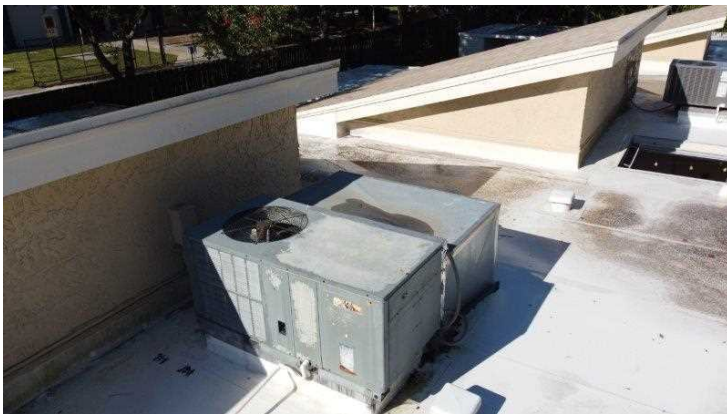
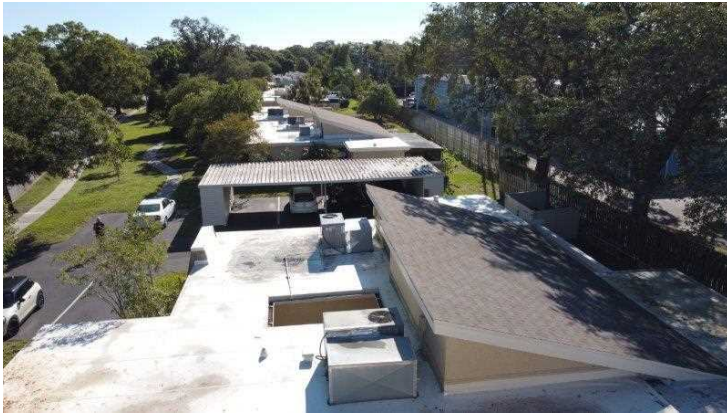
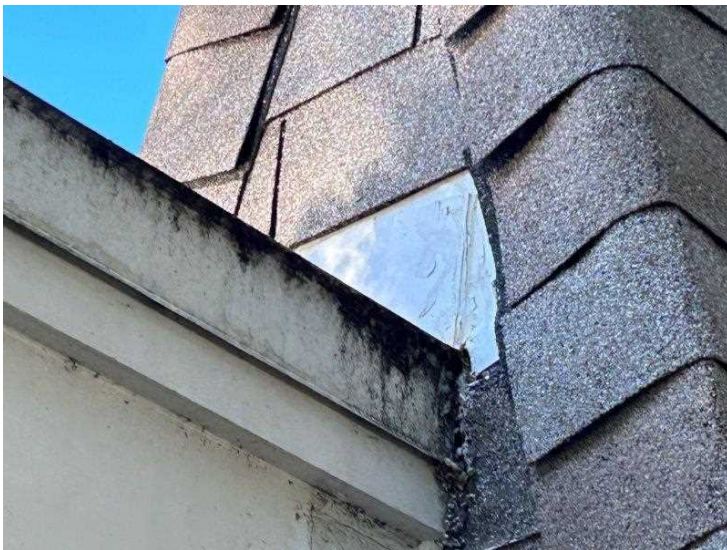
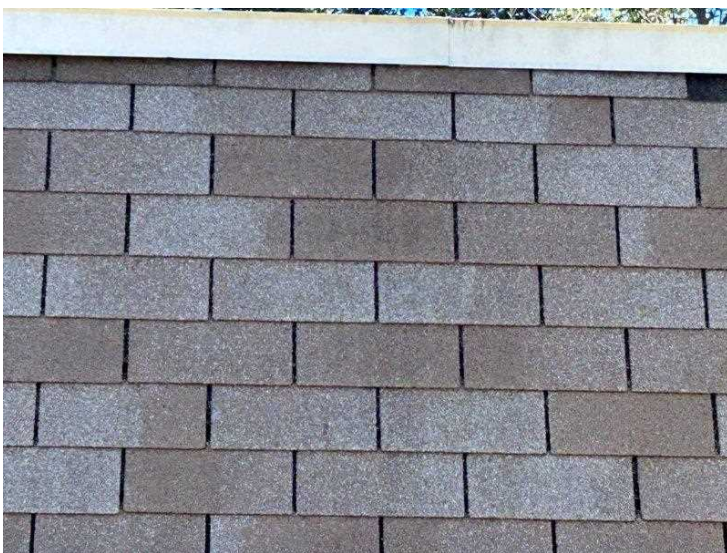
Roof Construction

| <b>2. Roof Covering:</b><br>Comments: | <b>FBC Equivalent</b><br>The flat roof covering was replaced in 2017. The roof permit was confirmed and the permit number is 17-00000361. The shingle roof covering appears to be modified; however, no permit information was found at the local building department. In our professional opinion the roof was replaced between 2011-2014, this was confirmed via historical imaging software. This roof was verified as meeting the requirements outlined on the mitigation affidavit. Refer to attached photos. |
