## Windstorm Mitigation Report (OIR-B1-1802)

Pipers Glen Condominium Association, Inc.

1577-1583 Amberlea Drive S

As of 9/21/2023 | FPAT File# MIT2320608

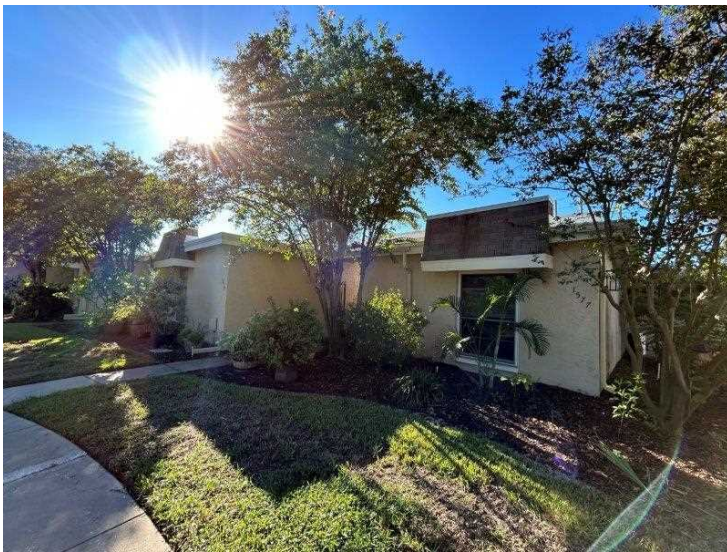
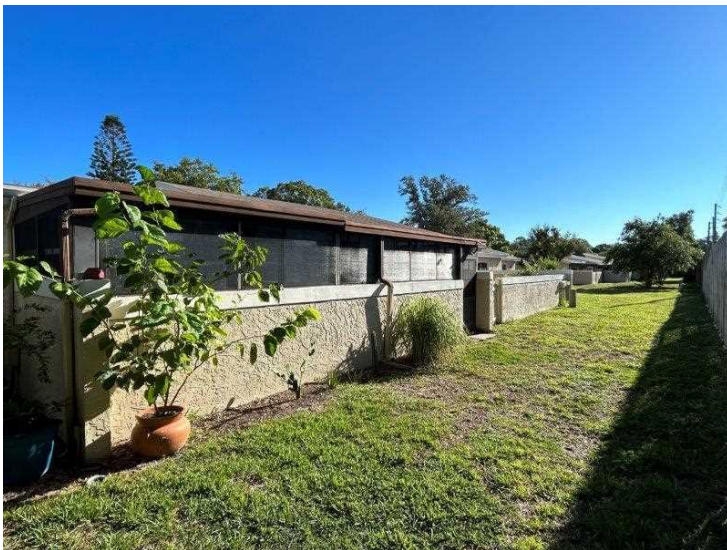
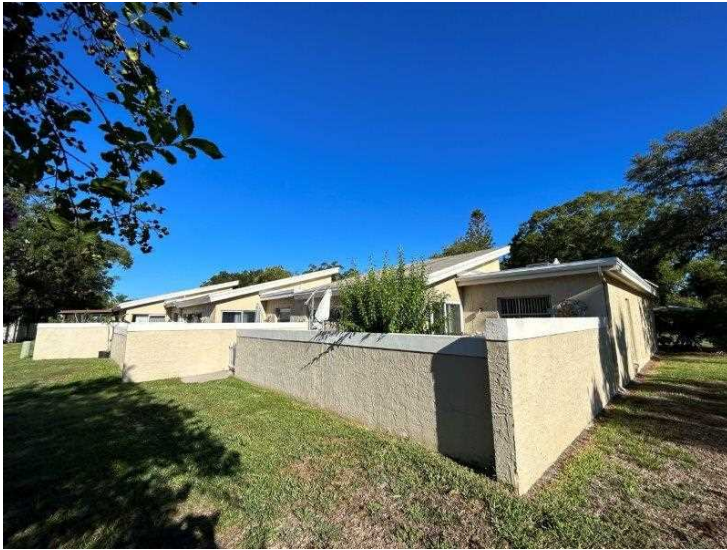
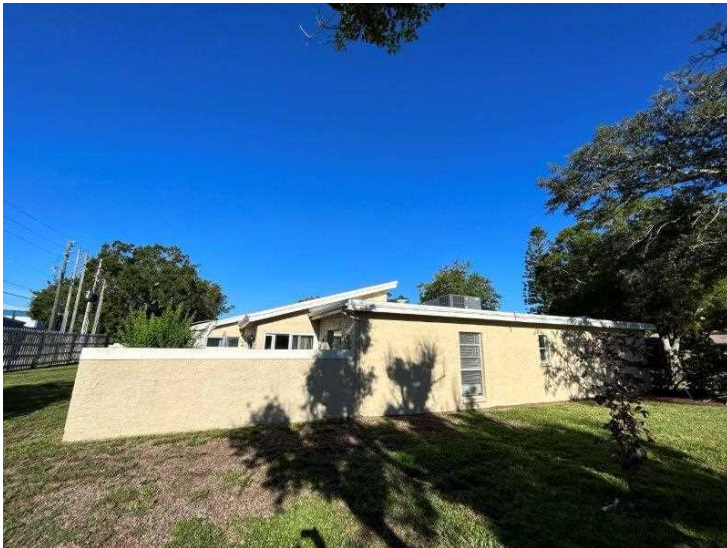
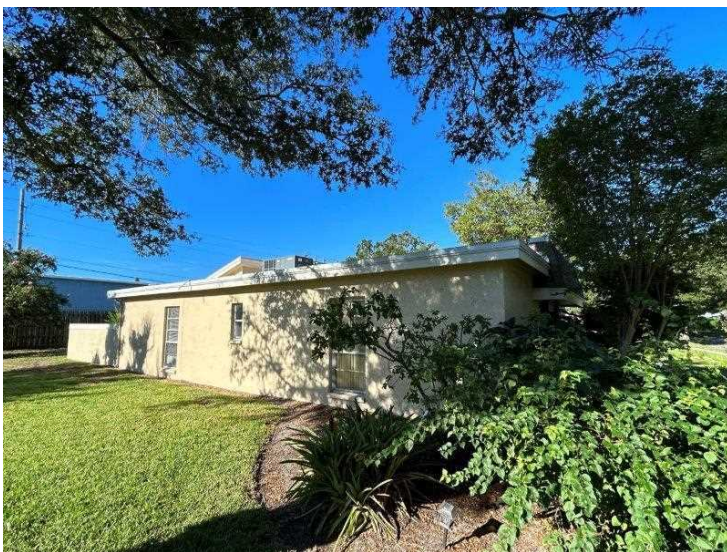
Exterior Elevation

| <b>5. Roof Geometry:</b><br>Comments: | <b>Other Roof</b><br>The roof shape is made up of a combination of flat and pitched sections. The flat area of the roof comprises approximately 71% of the total roof area. |

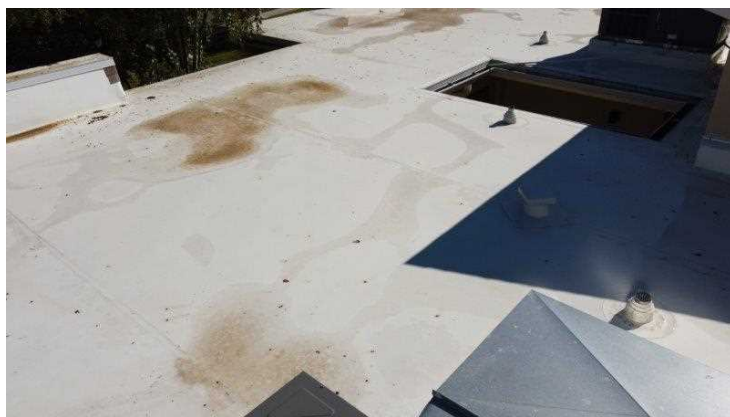
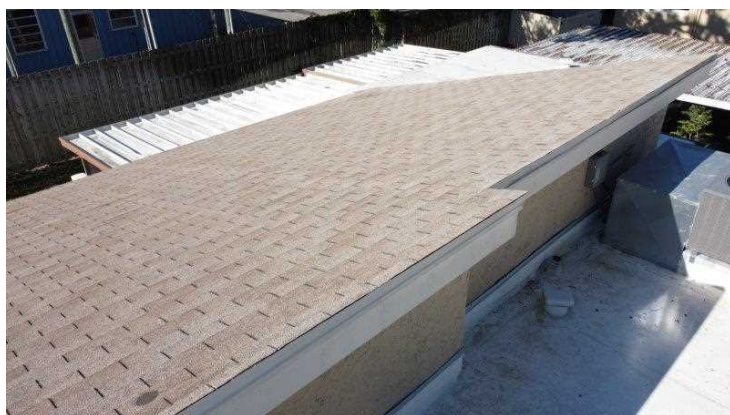
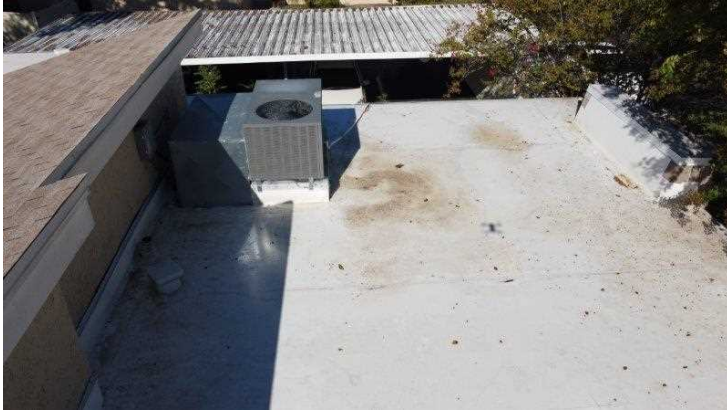
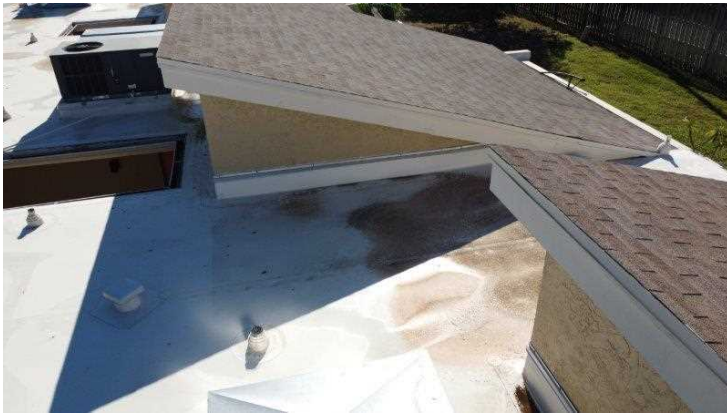
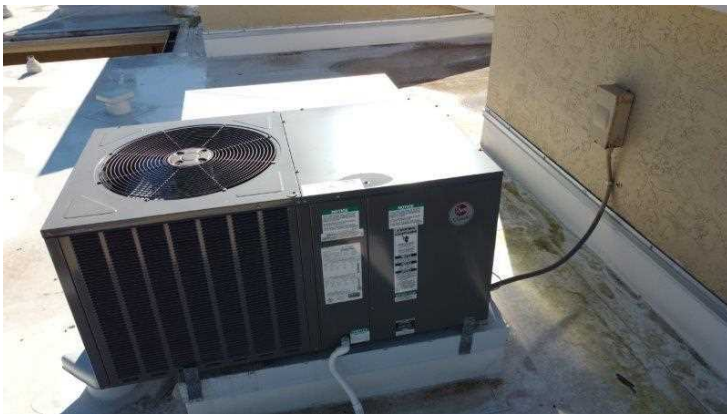
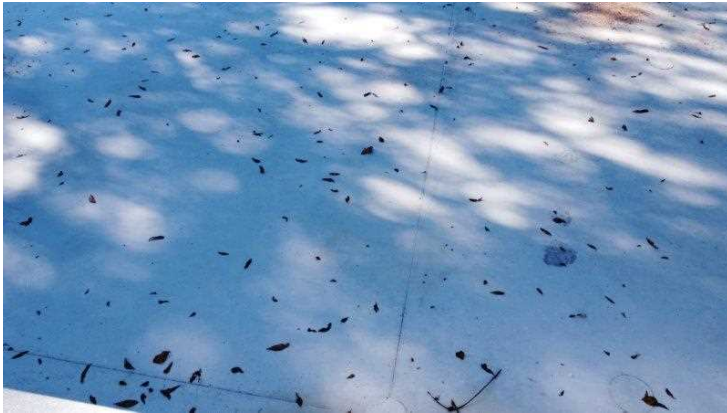
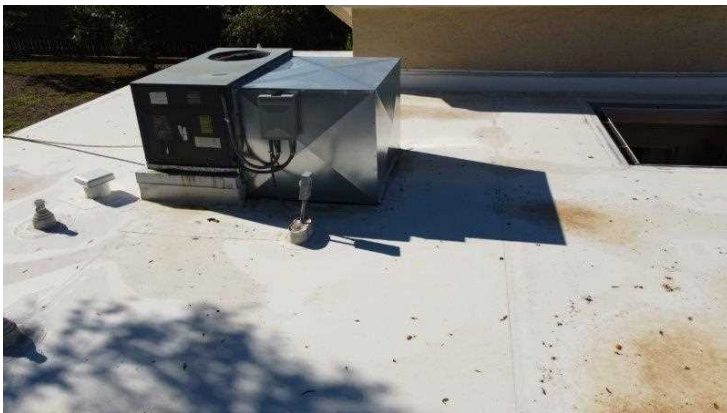
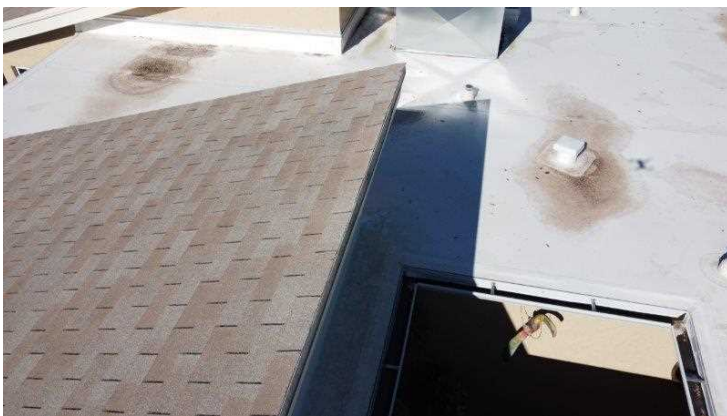
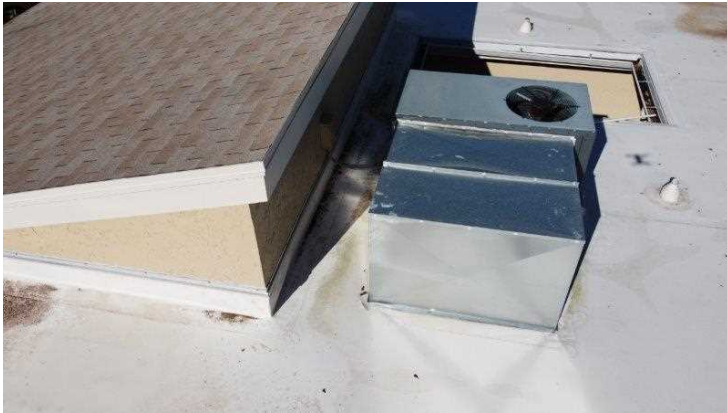
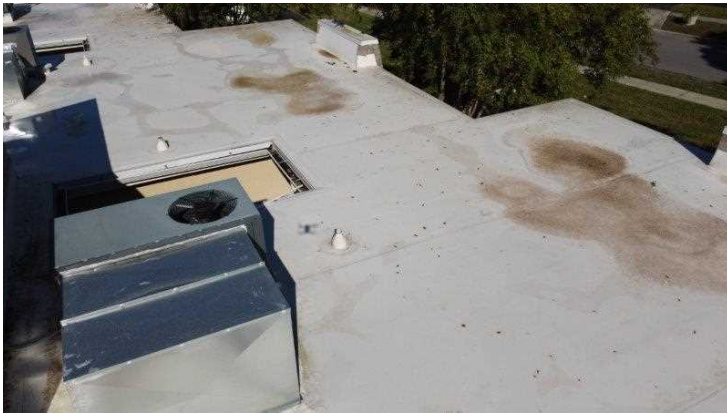
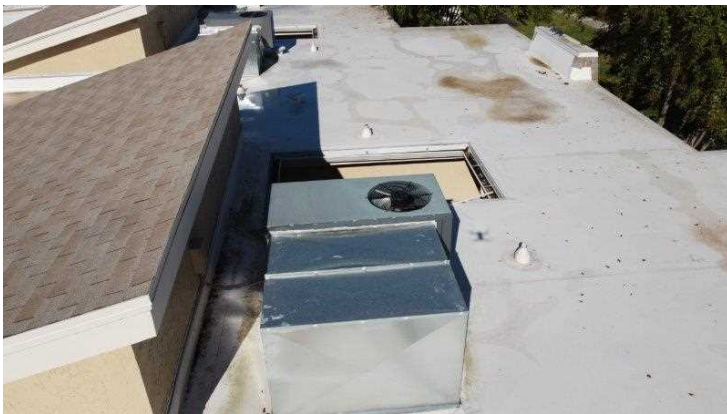
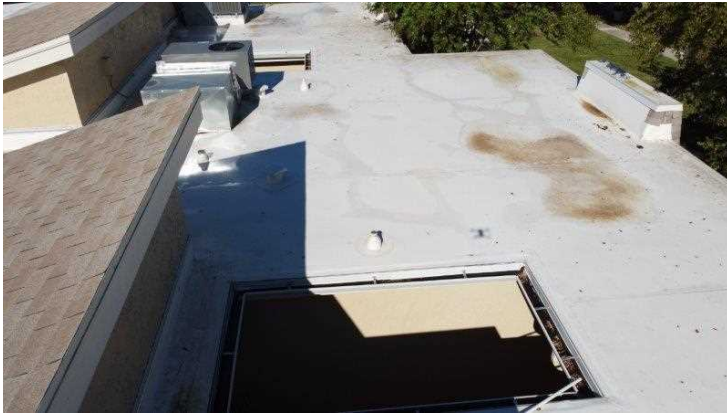
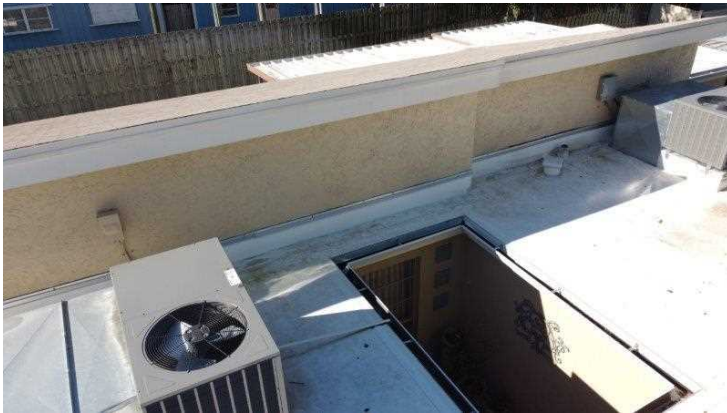
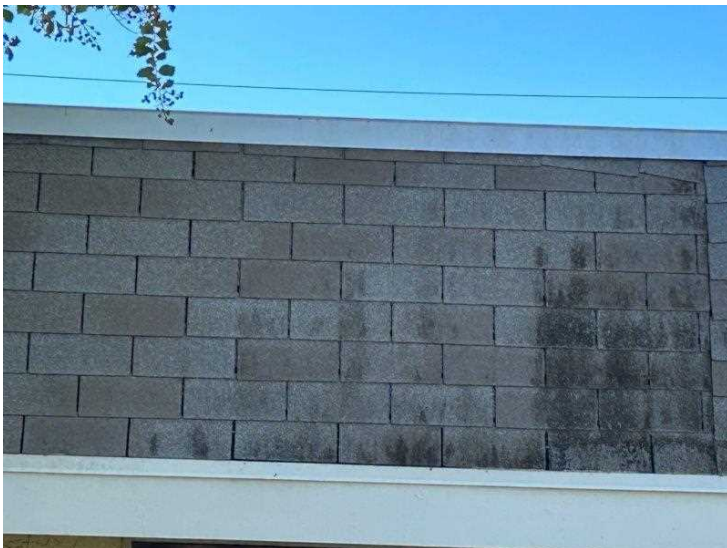
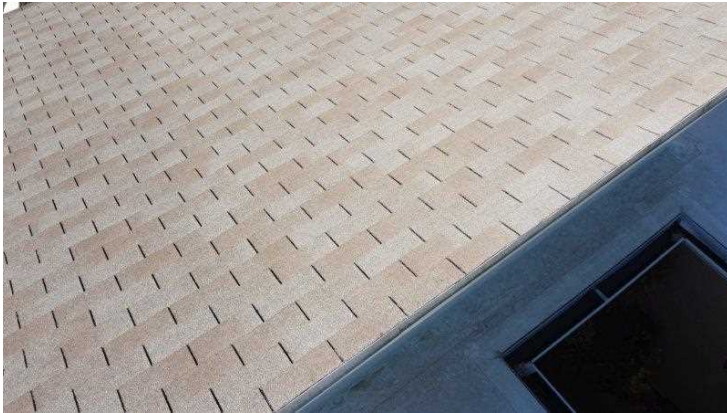
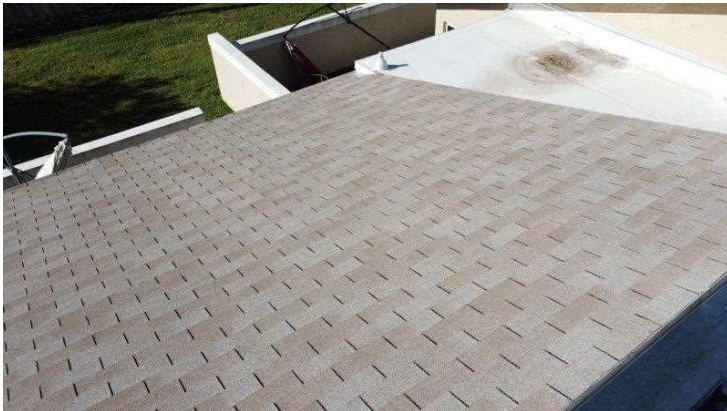
Roof Construction

| <b>2. Roof Covering:</b><br>Comments: | <b>FBC Equivalent</b><br>The flat roof covering was replaced in 2021. The roof permit was confirmed and the permit number is 21-00003030. The shingle roof covering appears to be modified; however, no permit information was found at the local building department. In our professional opinion the roof was replaced between 2011-2014, this was confirmed via historical imaging software. This roof was verified as meeting the requirements outlined on the mitigation affidavit. Refer to attached photos. |
