## Windstorm Mitigation Report (OIR-B1-1802)

Pipers Glen Condominium Association, Inc.

1582-1584 Heather Court

As of 9/21/2023 | FPAT File# MIT2320608

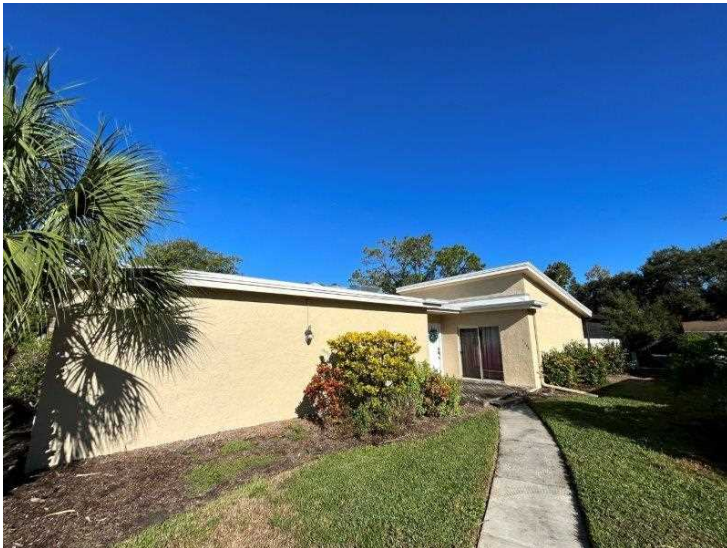
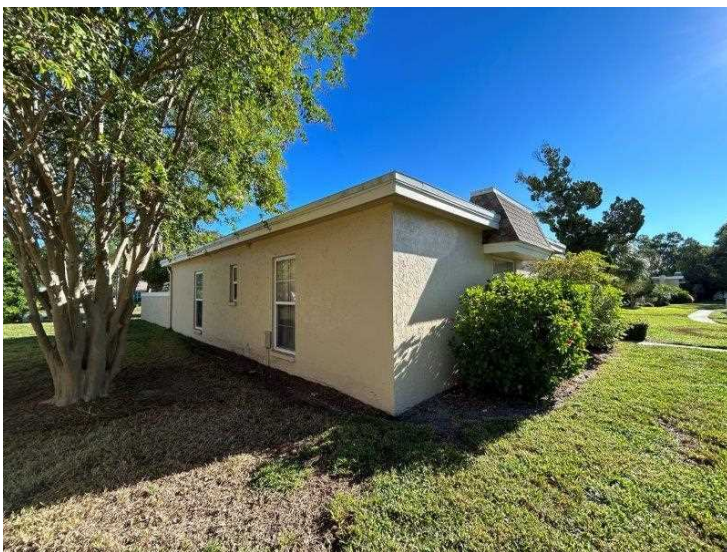
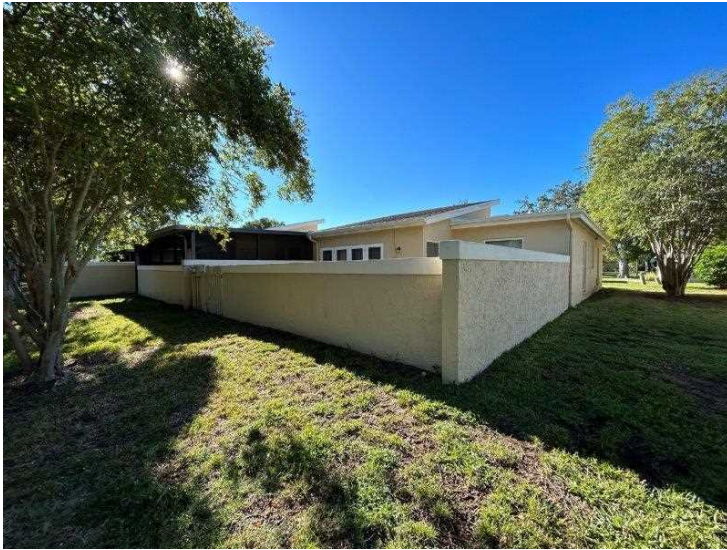
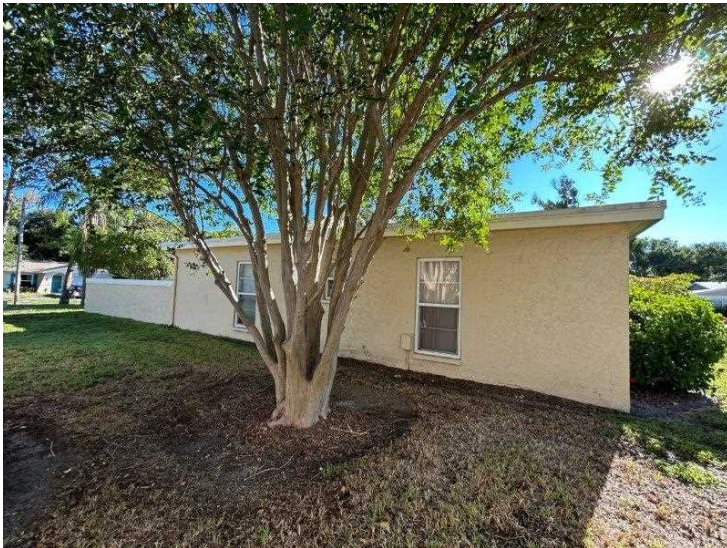
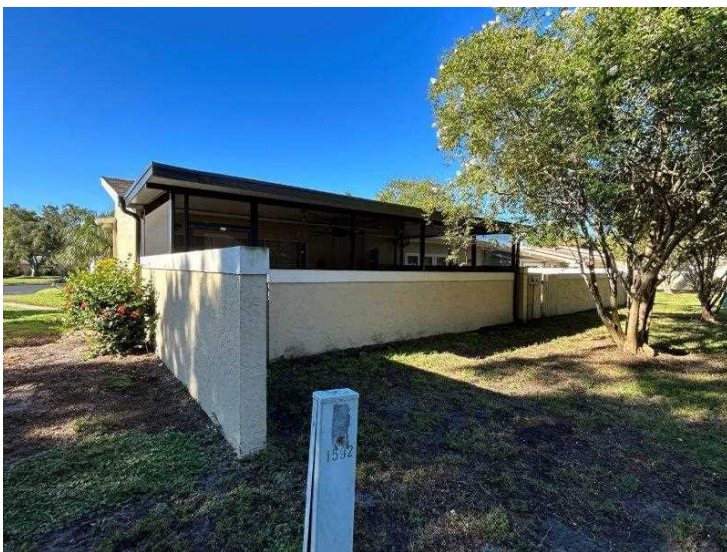
Exterior Elevation

| <b>7. Opening Protection:</b><br>Comments: | <b>None or Some Glazed Openings</b><br>Inspection verified no opening protection. |

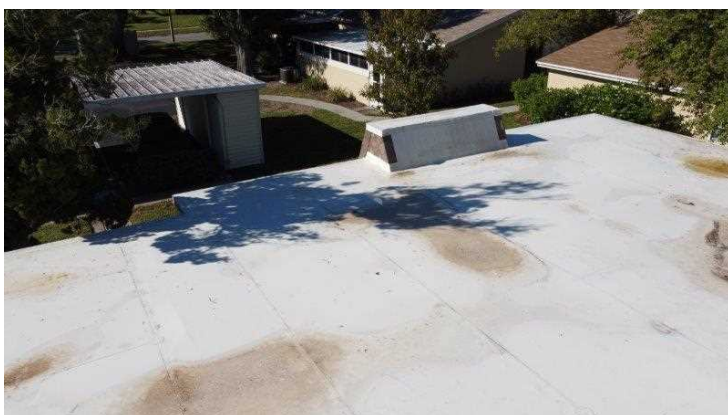
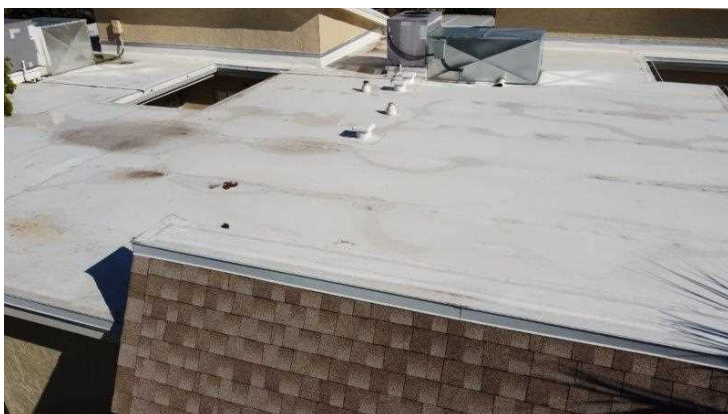
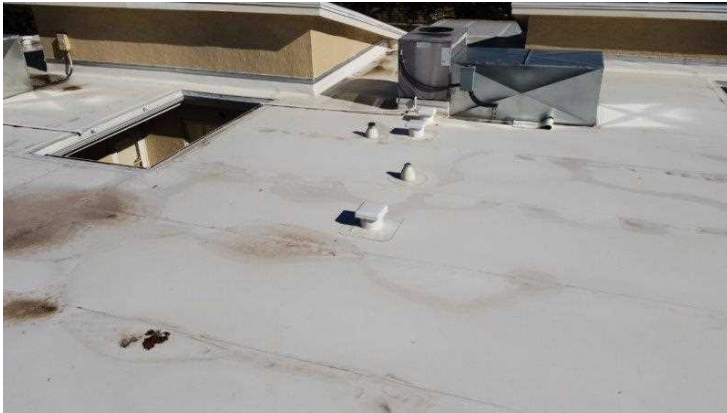
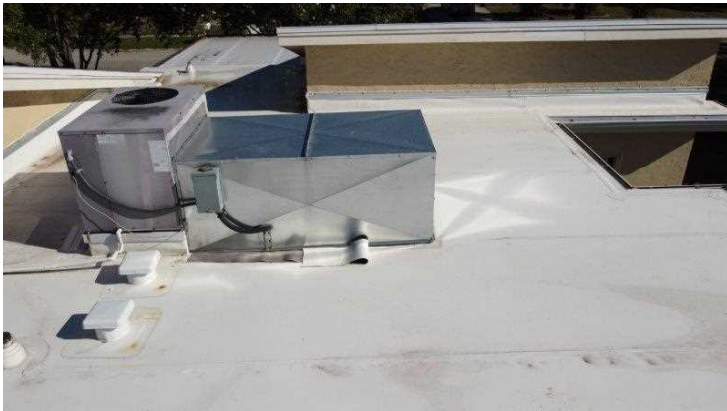
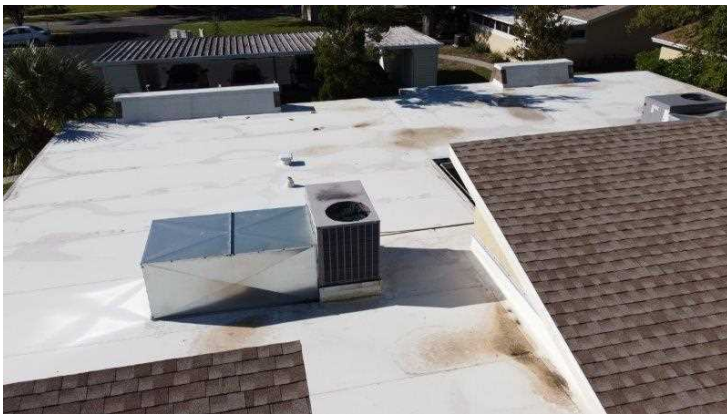
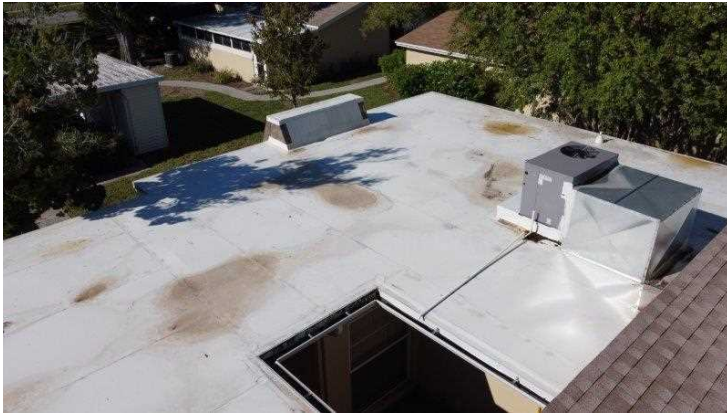
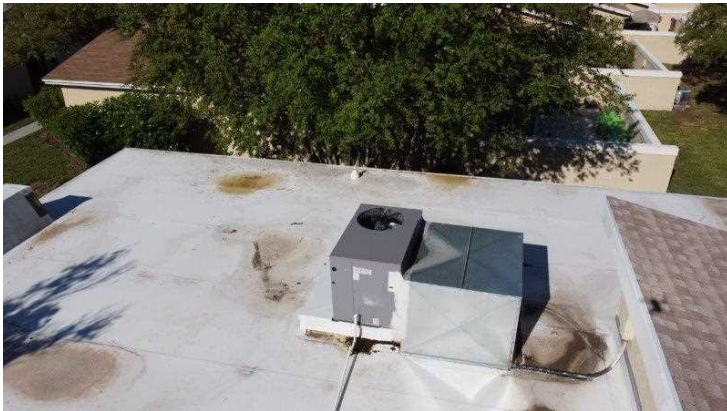
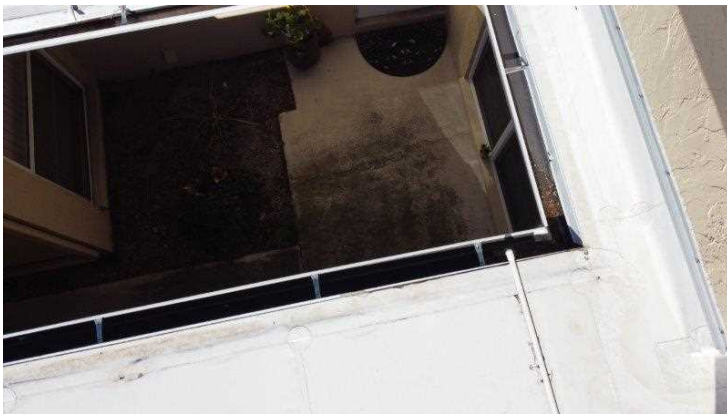
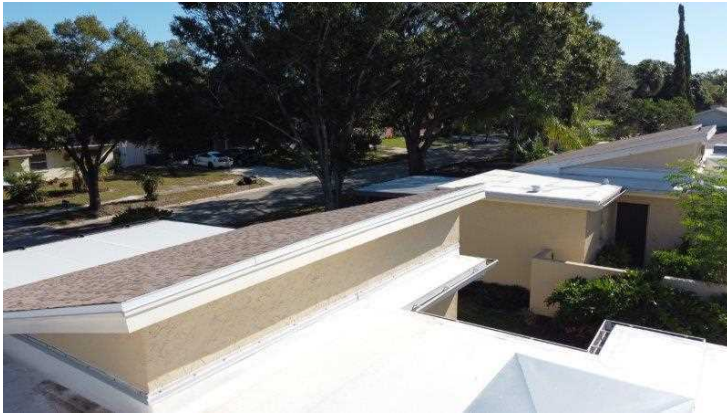
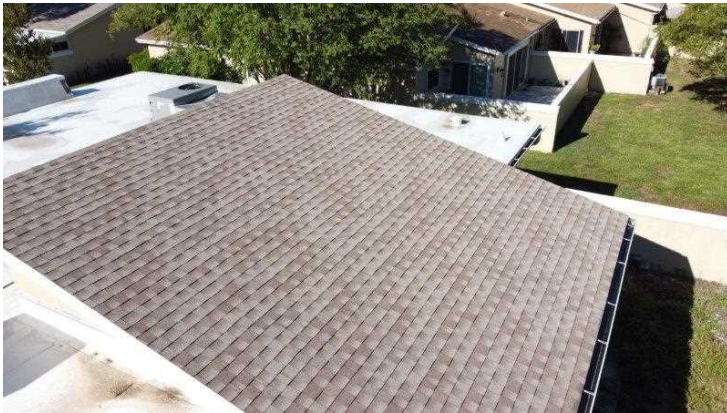
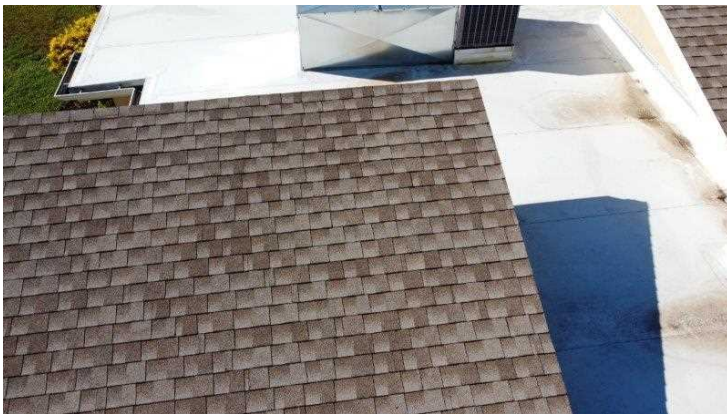
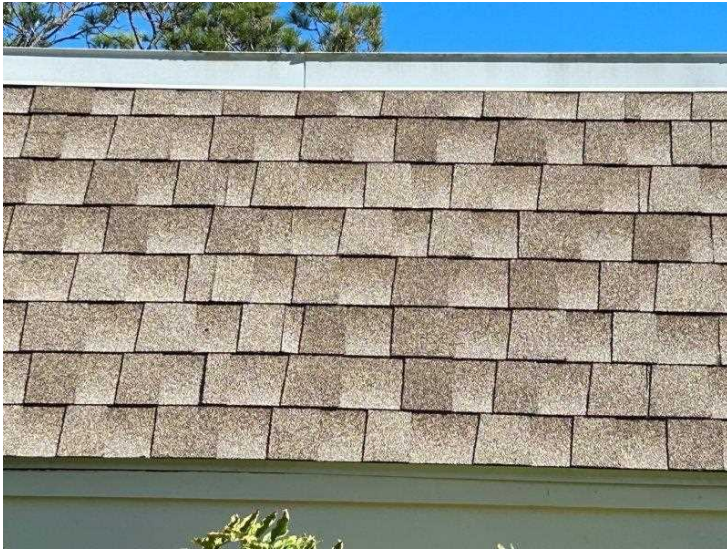
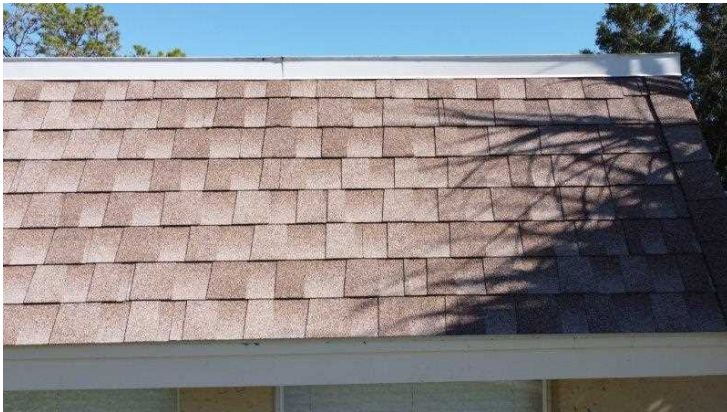
Roof Construction

| <b>2. Roof Covering:</b><br>Comments: | <b>FBC Equivalent</b><br>The roof covering was replaced in 2020. The roof permit was confirmed and the permit number is 20-00003773. This roof was verified as meeting the building code requirements outlined on the mitigation affidavit. |
| <b>5. Roof Geometry:</b><br>Comments: | <b>Other Roof</b><br>The roof shape is made up of a combination of flat and pitched sections. The flat area of the roof comprises approximately 71% of the total roof area. |
| <b>6. SWR:</b><br>Comments: | <b>Unknown or Undetermined</b><br>At the time of inspection, no SWR was verified. |
