## Windstorm Mitigation Report (OIR-B1-1802)

Pipers Glen Condominium Association, Inc.

1585-1591 Amberlea Drive S

As of 9/21/2023 | FPAT File# MIT2320608

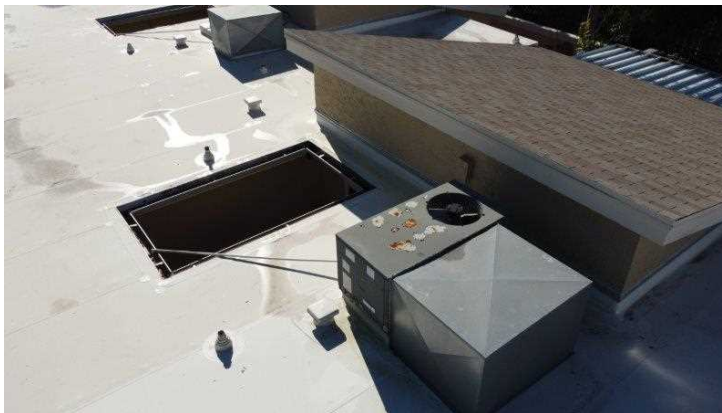
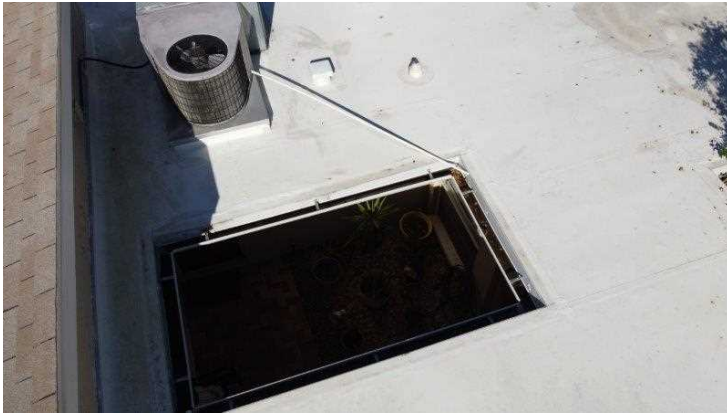
Roof Construction

| <b>5. Roof Geometry:</b><br>Comments: | <b>Other Roof</b><br>The roof shape is made up of a combination of flat and pitched sections. The flat area of the roof comprises approximately 71% of the total roof area. |
