## Windstorm Mitigation Report (OIR-B1-1802)

Pipers Glen Condominium Association, Inc.

1586-1592 Heather Court

As of 9/21/2023 | FPAT File# MIT2320608

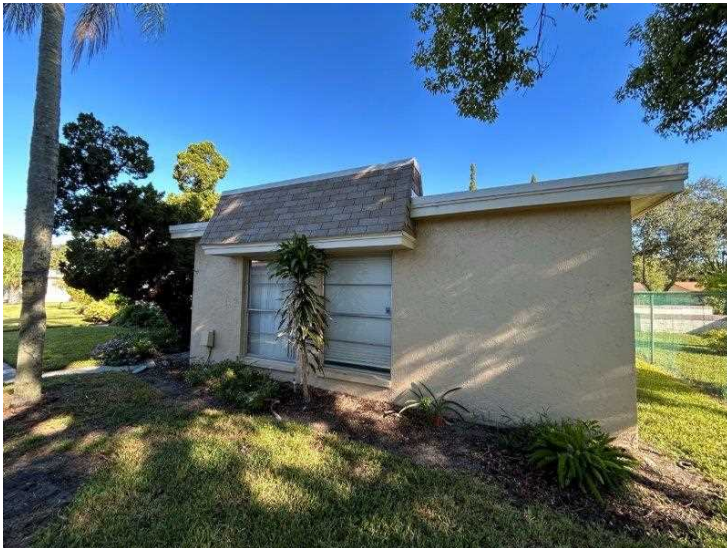
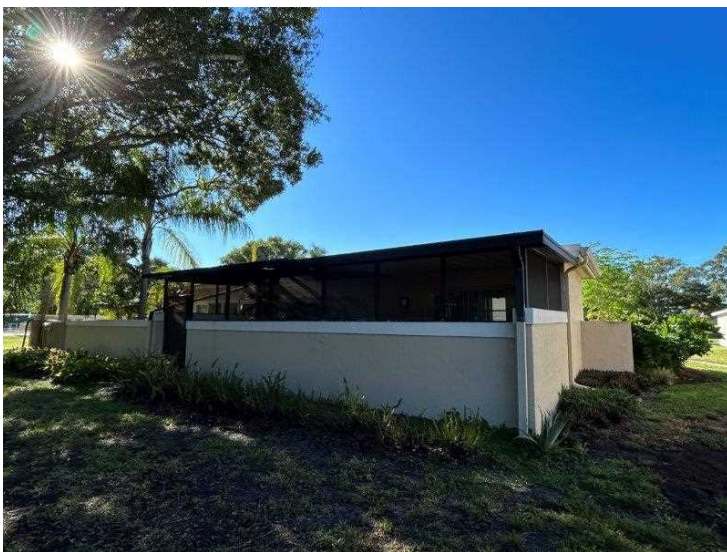
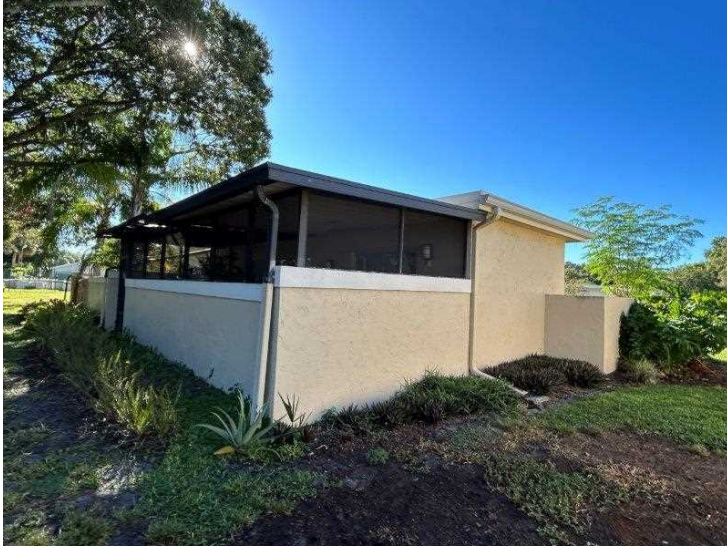
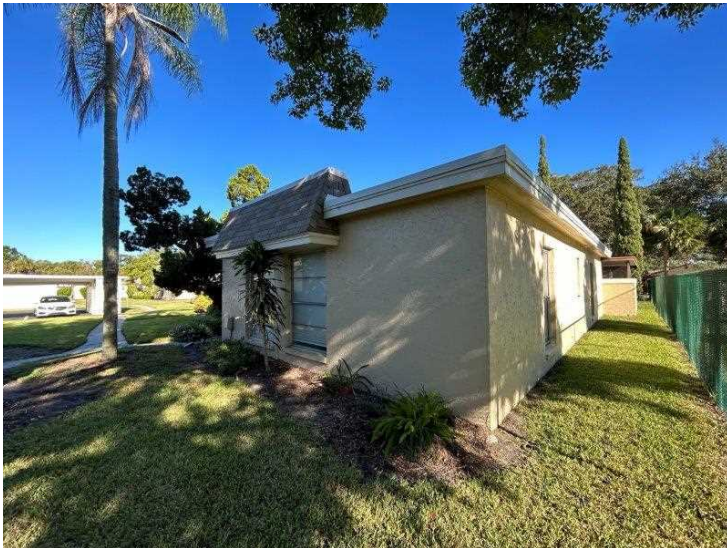
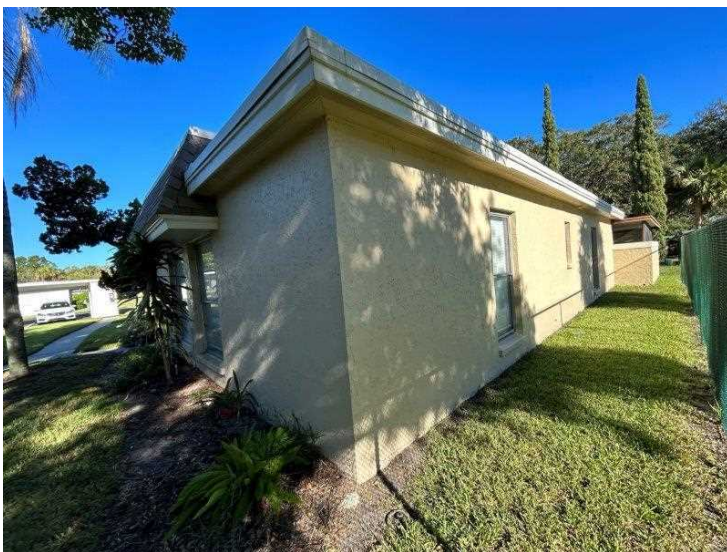
Exterior Elevation

| <b>5. Roof Geometry:</b><br>Comments: | <b>Other Roof</b><br>The roof shape is made up of a combination of flat and pitched sections. The flat area of the roof comprises approximately 71% of the total roof area. |
| <b>7. Opening Protection:</b><br>Comments: | <b>None or Some Glazed Openings</b><br>Inspection verified no opening protection. |

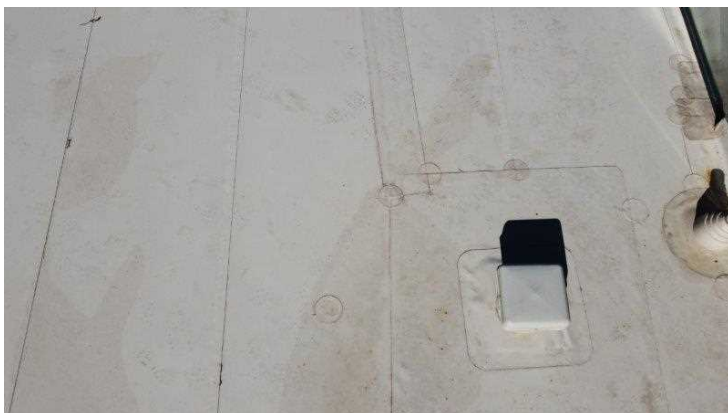
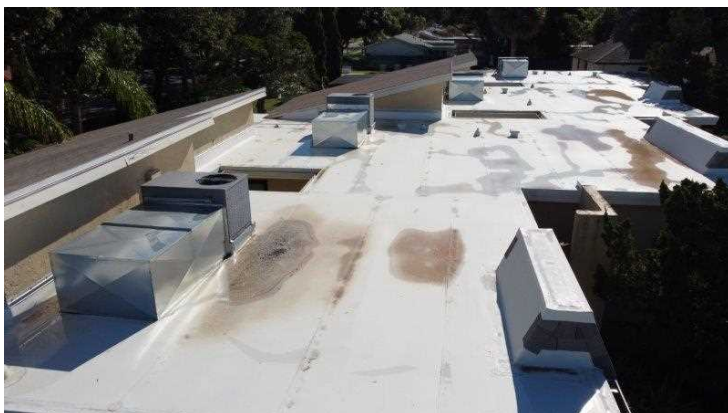
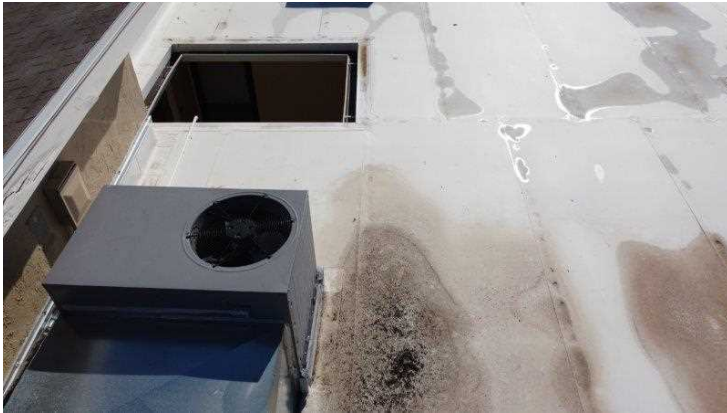
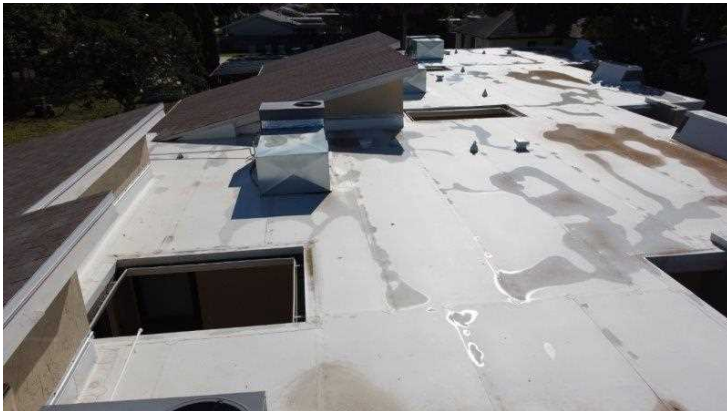
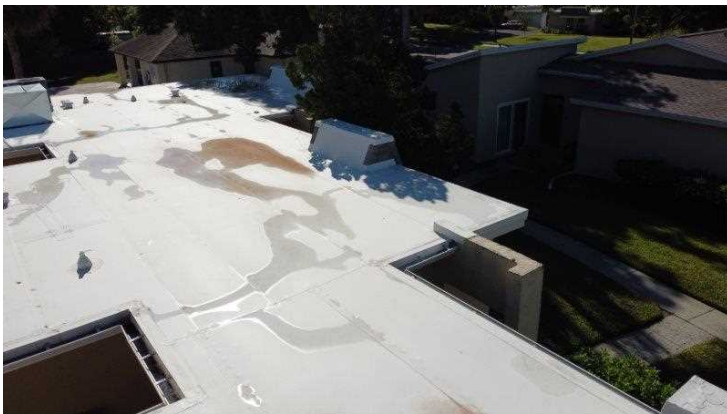
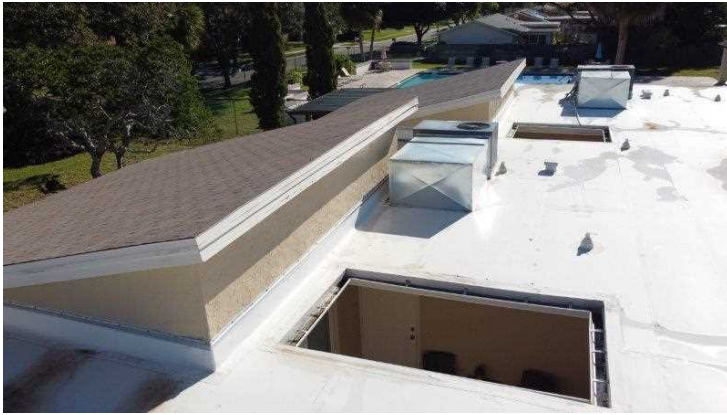
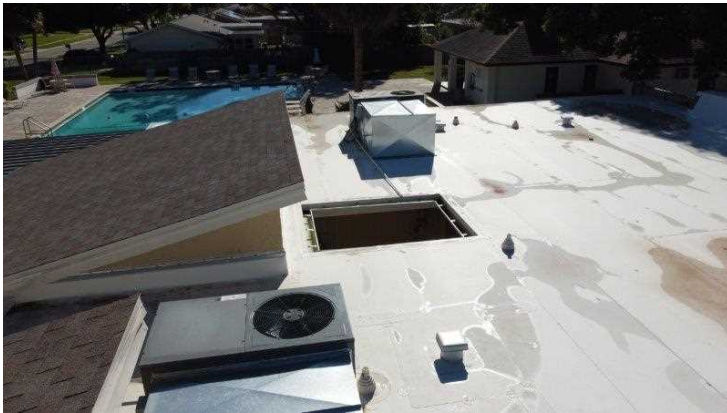
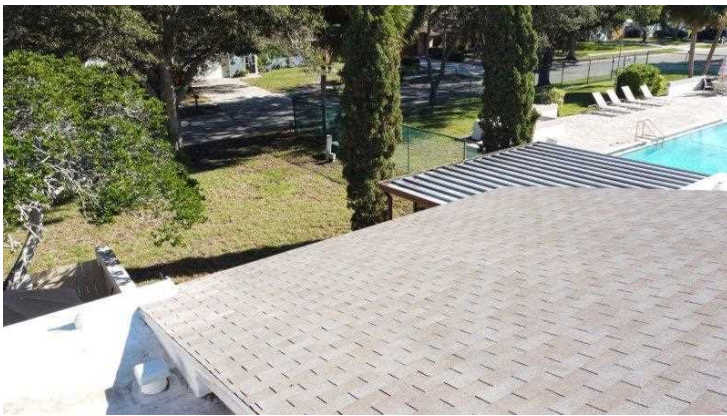
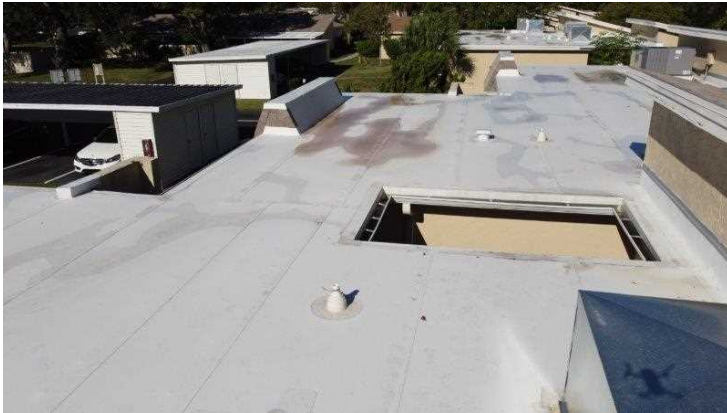
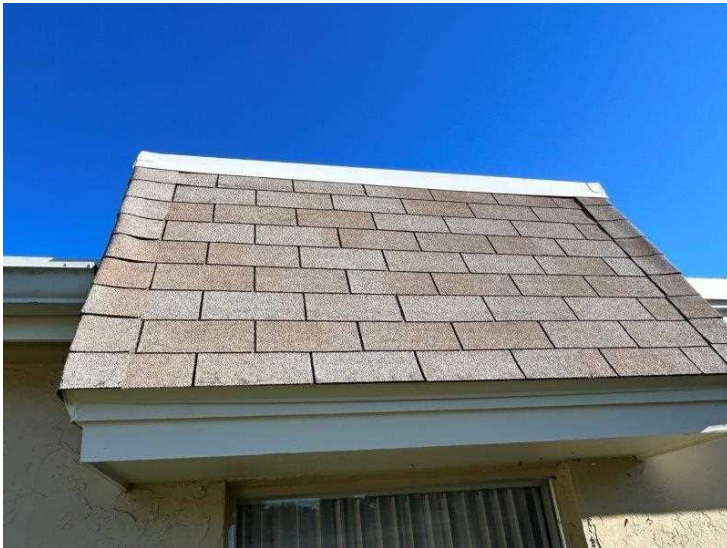
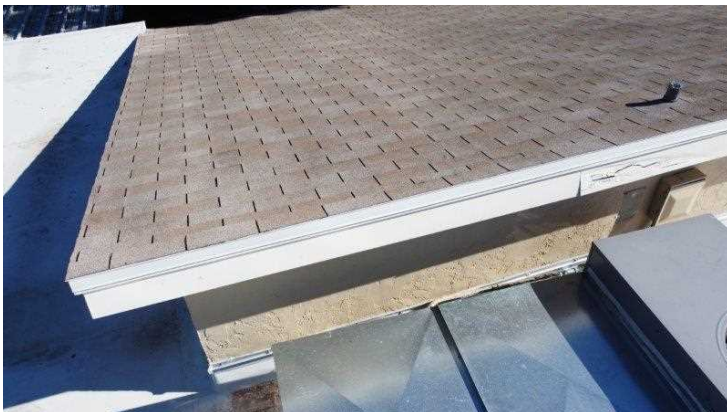
Roof Construction

| <b>2. Roof Covering:</b><br>Comments: | <b>One or more roof coverings do not meet the minimum requirements</b><br>The flat roof covering was replaced in 2022. The roof permit was confirmed and the permit number is 22-00001943. According to the association records The shingle roof covering was replaced in 2010; however, no permit information was found with the local Building Department. If additional information is provided the report will be revised. appears to be modified; however, no permit information was found at the local building department. |
| <b>6. SWR:</b><br>Comments: | <b>Unknown or Undetermined</b><br>At the time of inspection, no SWR was verified. |
