## Windstorm Mitigation Report (OIR-B1-1802)

Pipers Glen Condominium Association, Inc.

1593-1599 Amberlea Drive S

As of 9/21/2023 | FPAT File# MIT2320608

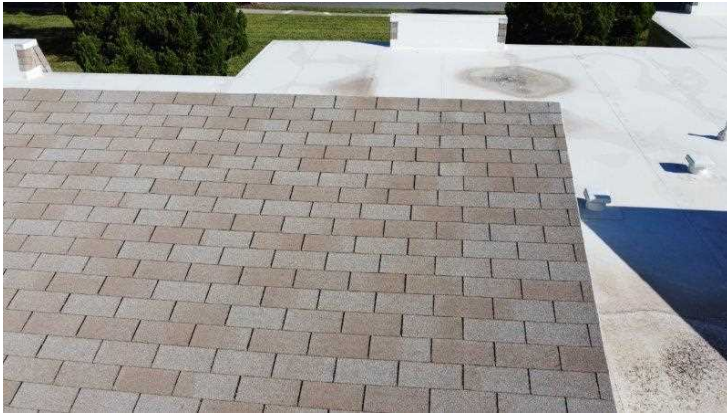
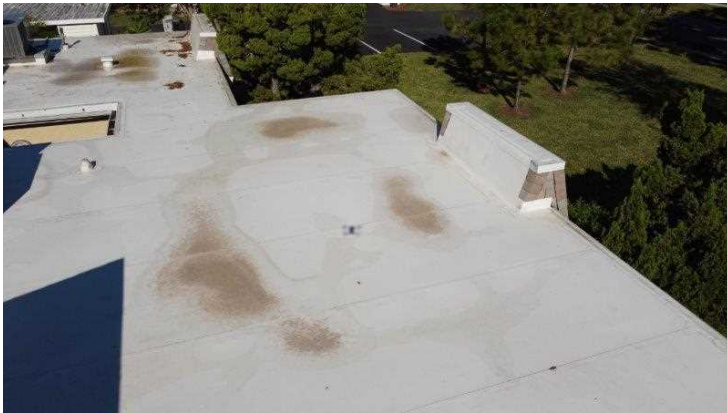
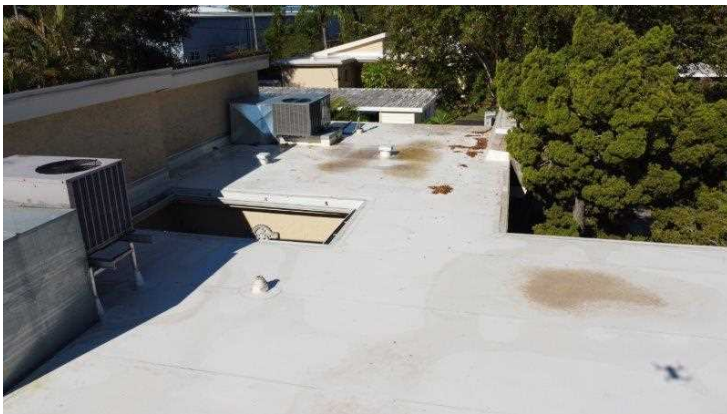
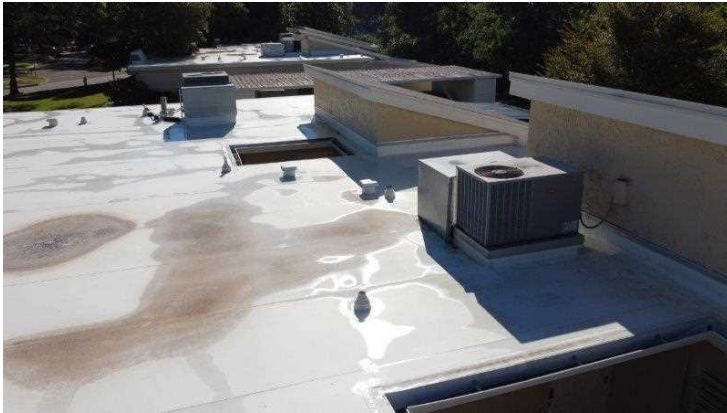
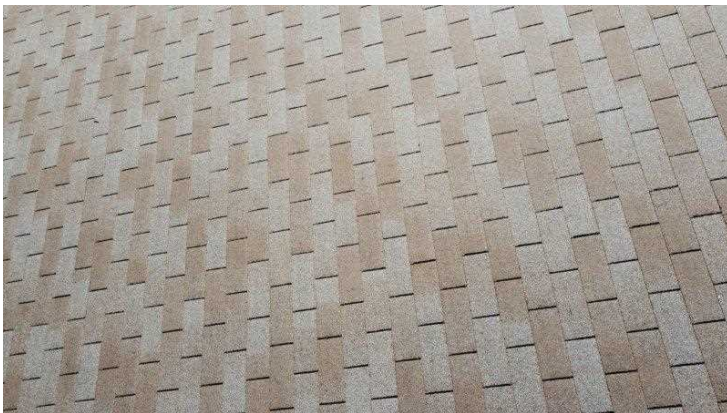
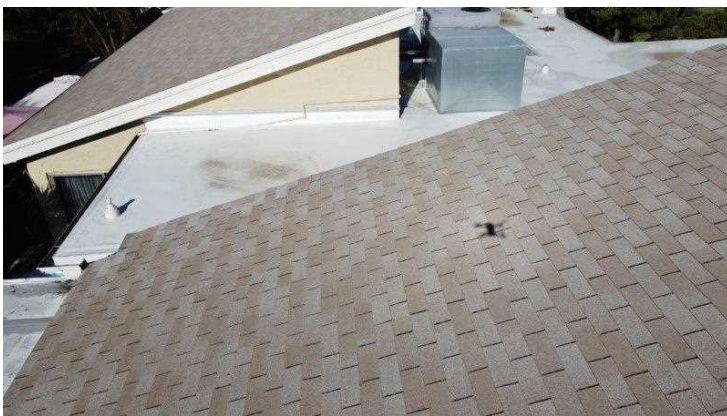
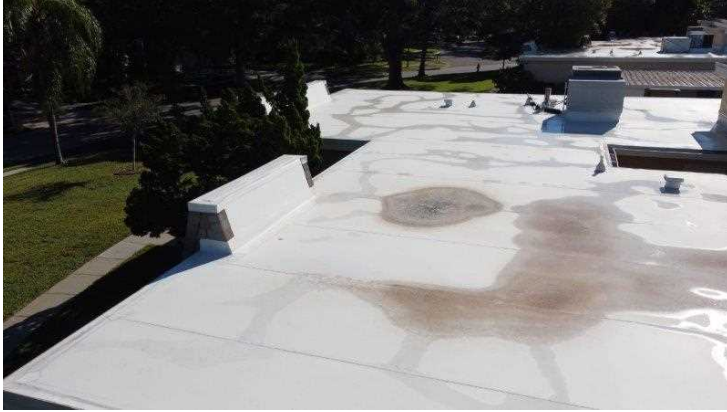
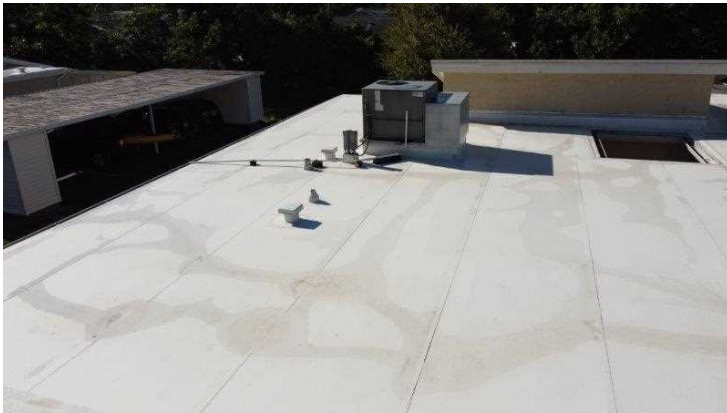
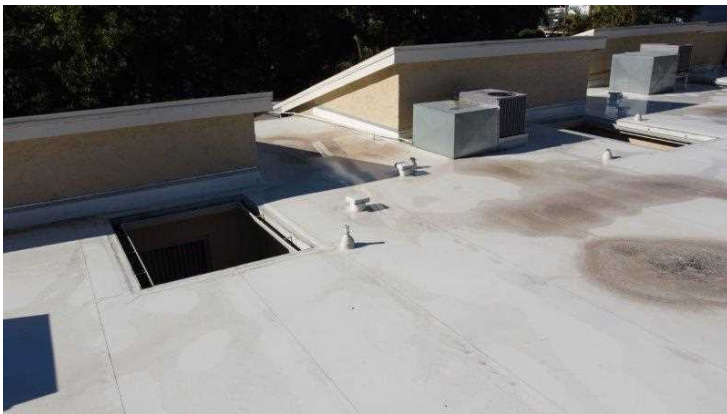
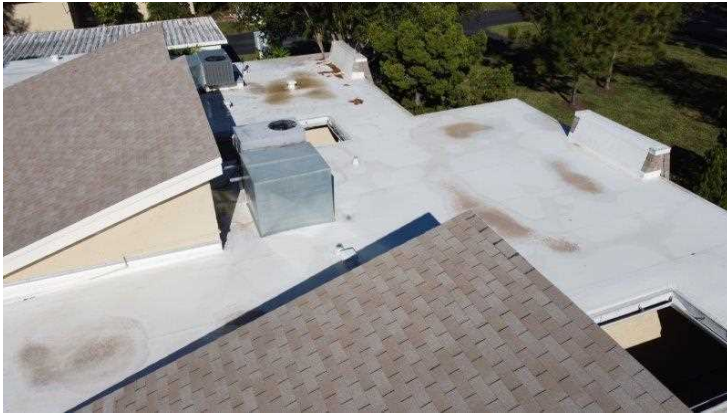
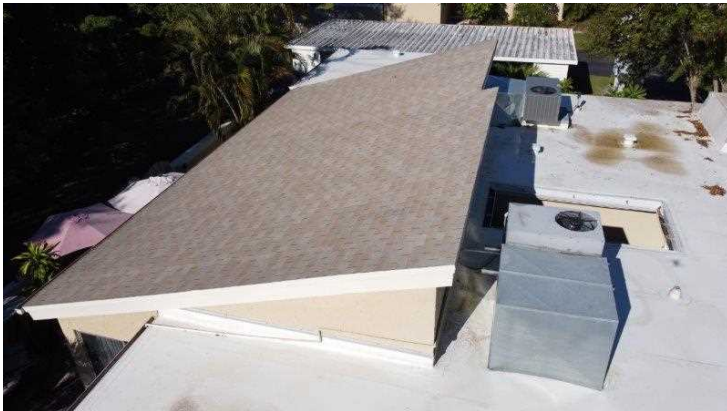
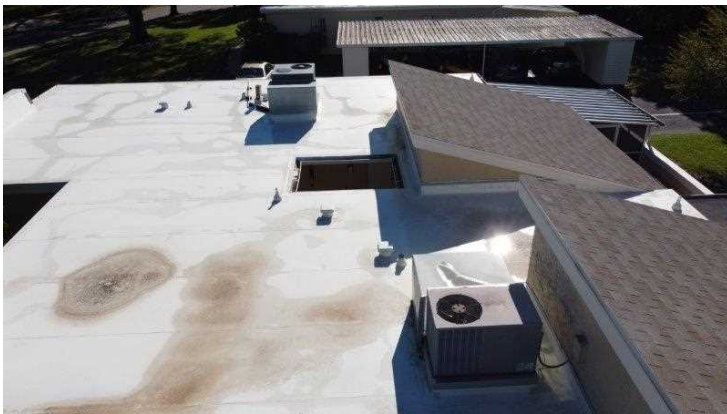
Roof Construction

| <b>2. Roof Covering:</b><br>Comments: | <b>FBC Equivalent</b><br>The flat roof covering was replaced in 2020. The roof permit was confirmed and the permit number is 20-00001359. The shingle roof covering appears to be modified; however, no permit information was found at the local building department. In our professional opinion the roof was replaced between 2011-2014, this was confirmed via historical imaging software. This roof was verified as meeting the requirements outlined on the mitigation affidavit. Refer to attached photos. |
| <b>5. Roof Geometry:</b><br>Comments: | <b>Other Roof</b><br>The roof shape is made up of a combination of flat and pitched sections. The flat area of the roof comprises approximately 71% of the total roof area. |
