## Windstorm Mitigation Report (OIR-B1-1802)

Pipers Glen Condominium Association, Inc.

1601-1607 Amberlea Drive S

As of 9/21/2023 | FPAT File# MIT2320608

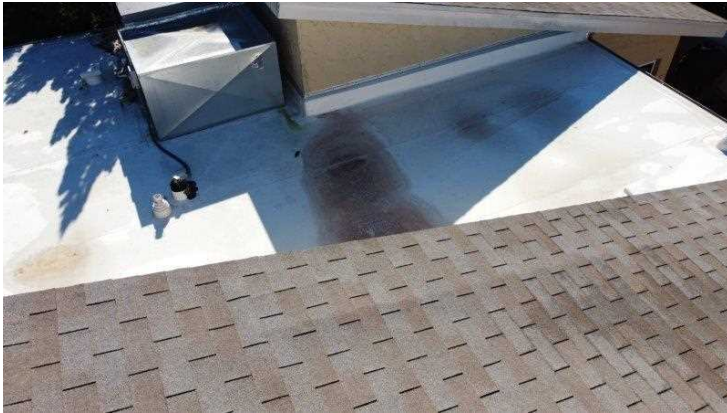
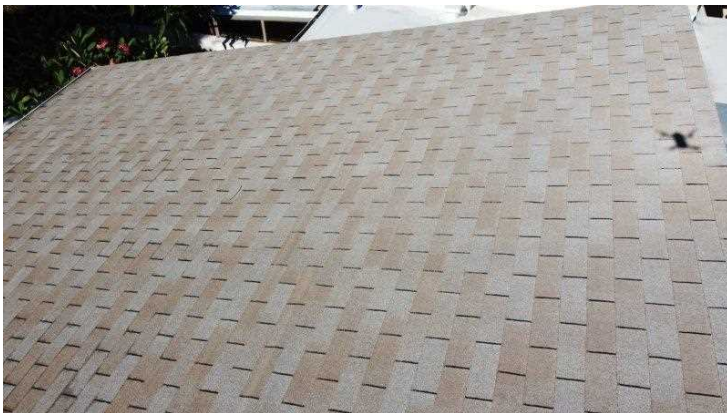
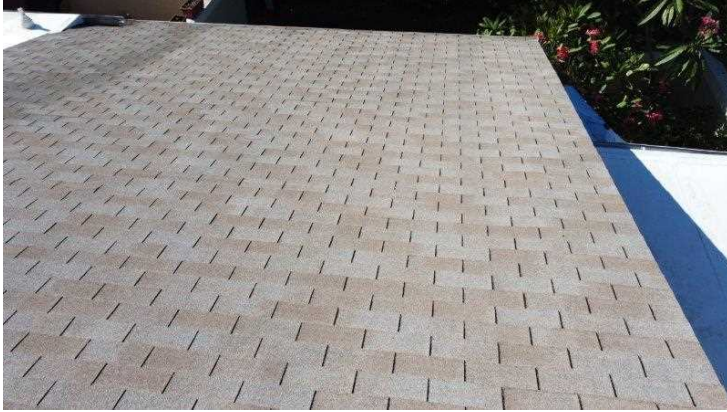
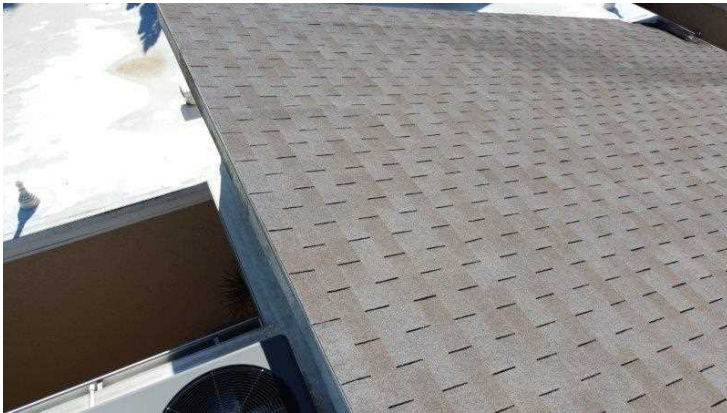
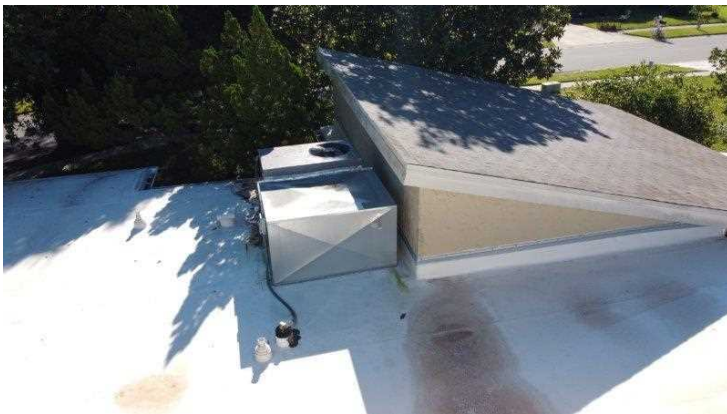
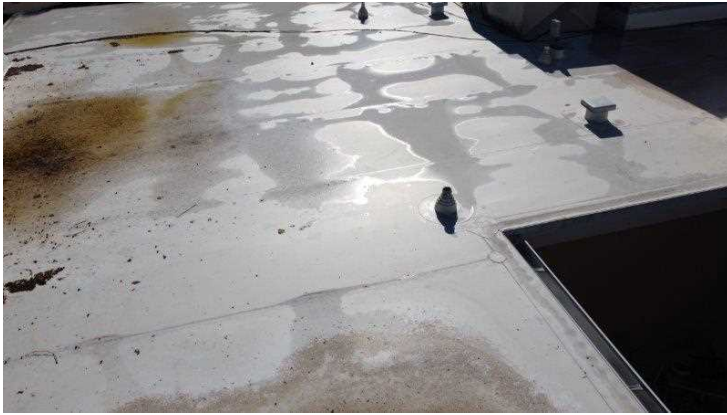
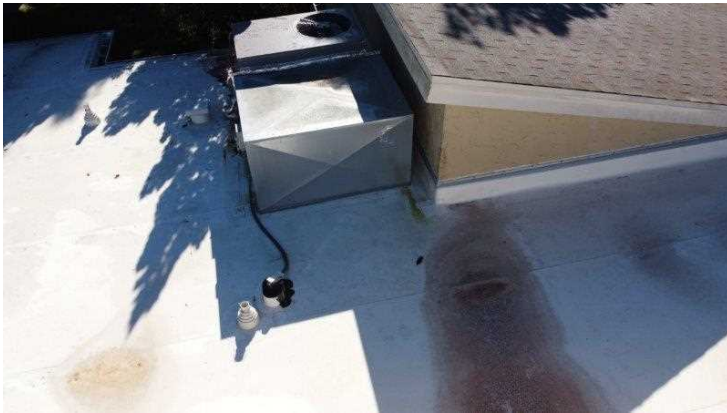
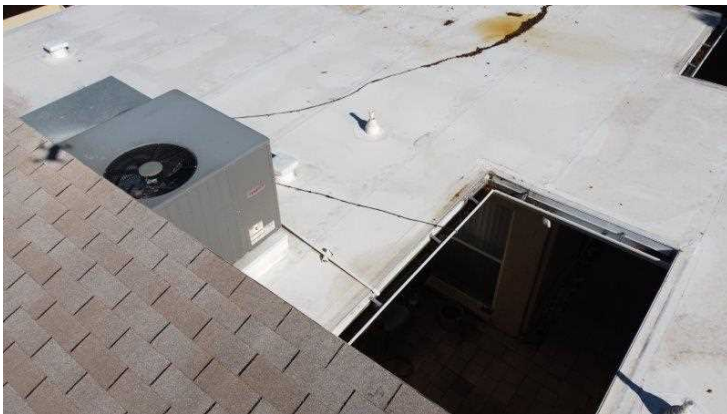
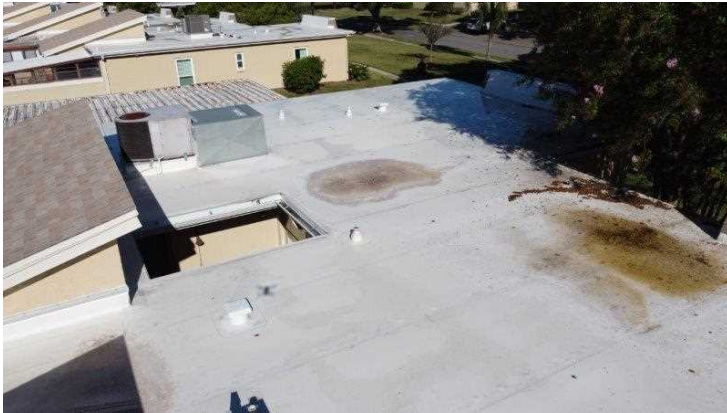
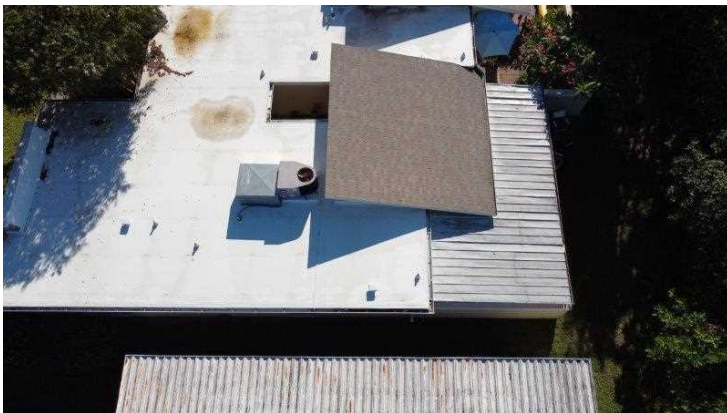
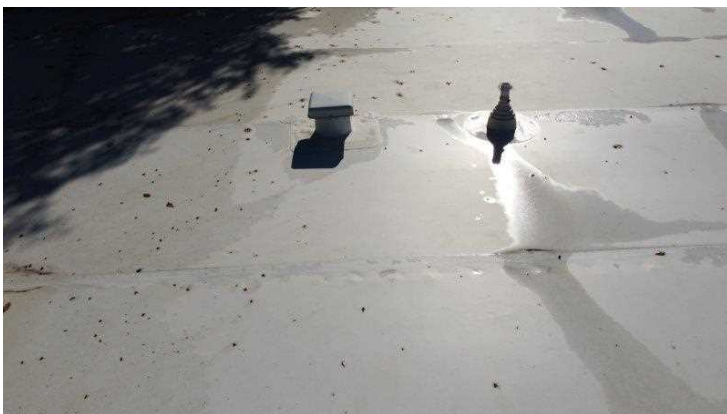
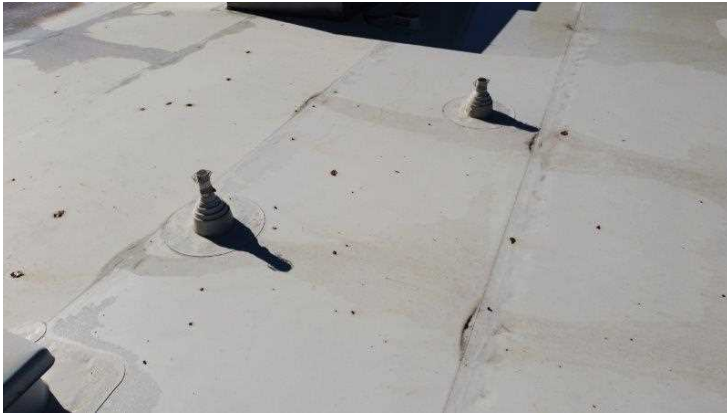
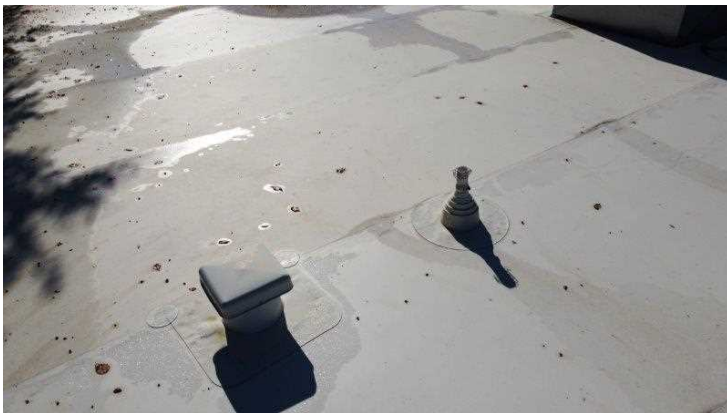
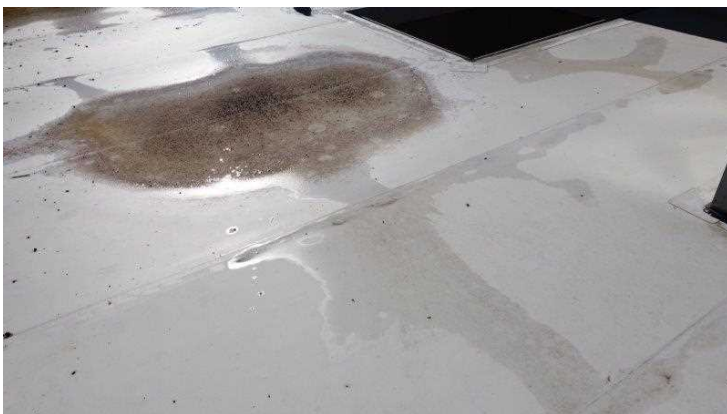
Roof Construction

| <b>2. Roof Covering:</b><br>Comments: | <b>FBC Equivalent</b><br>The flat roof covering was replaced in 2019. The roof permit was confirmed and the permit number is 19-00003766. The age of the shingle roof covering is unknown. No permit information was found with the local building department or provided by the association. If additional information becomes available, this report will be revised. |
| <b>5. Roof Geometry:</b><br>Comments: | <b>Other Roof</b><br>The roof shape is made up of a combination of flat and pitched sections. The flat area of the roof comprises approximately 71% of the total roof area. |
